A WET-STEAM PIPELINE FRACTURE PRELOM CEVOVODA ZA VLAŽNO PARO

Roman Celin, Dimitrij Kmetič

Institute of Metals and Technology, Lepi pot 11, 1000 Ljubljana, Slovenia
roman.celin@imt.si

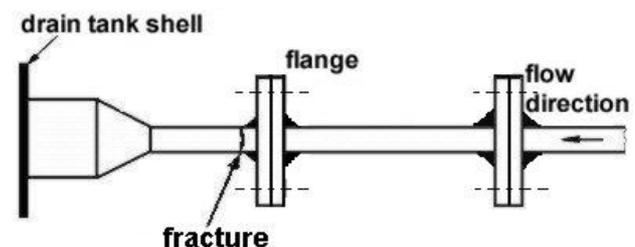
After 25 years in operation a failure occurred in a low-pressure wet-steam pipeline. This failure was not a catastrophic one, but it was severe enough to halt the operation of the system. **Figure 1** shows a sketch of the pipeline and the position of the fracture. In this case the fracture occurred in the heat-affected zone of the flange's fillet weld.

Figure 1: Sketch of the wet-steam pipeline with the fracture
Slika 1: Skica cevovoda mokre pare z mestom preloma

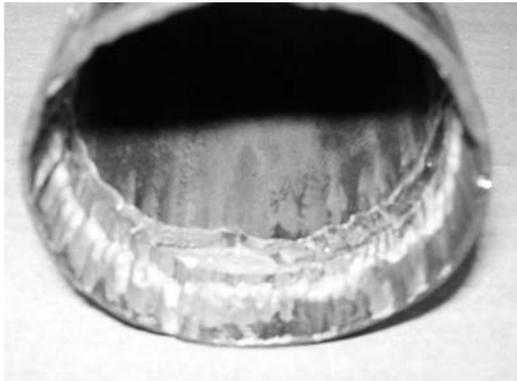
Figure 2: Tube with fracture and erosion-corrosion damage
Slika 2: Cev s prelomom in poškodbami zaradi erozije – korozije

A visual examination of the inside area of the fractured tube revealed a substantial loss of metal, which is shown in **Figure 2**. The minimum thickness of the tube was 3 mm. The affected area was smooth with wavelike contours⁵. The minimum distance between the affected area and the fracture was of 6 mm. Flanges are not shown on **Figure 2**, because they were cut off.

The metal loss is oriented along the direction of the wet steam's flow and it is a classic feature of erosion-corrosion, which can be defined as the accelerated degradation of a material resulting from the joint action of erosion and corrosion when the material is exposed to rapidly moving droplets of water in a steam flow⁶.

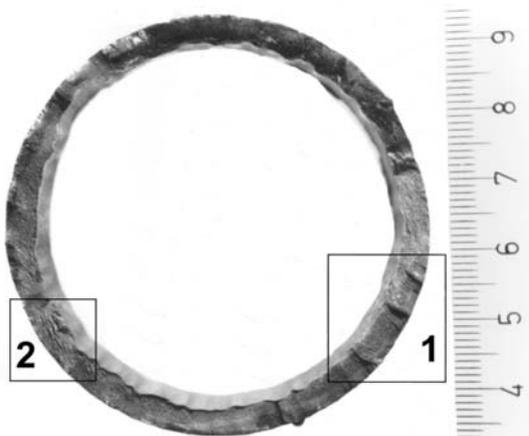
Figure 3 shows the tube's fracture surface. One area of the initial crack is marked with the number 1, and it is

Figure 3: Tube fracture surface
Slika 3: Površina preloma cevi

Ridges are visible on the fracture surface marked with the number 2 in **Figure 3**. The details are shown in **Figure 5**.

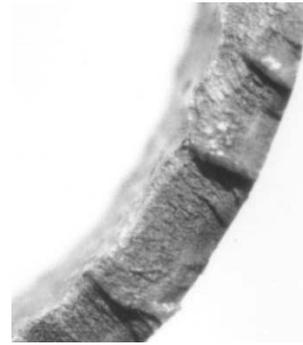
Figure 4: Fatigue crack surface
Slika 4: Površina utrujenostne razpoke

shown in more detail in **Figure 4**. It is clear that the initial crack propagated in the circumferential direction more quickly than in the radial direction.

The microstructure in the initial and fatigue-crack propagation area is typical for an overheated steel. In the area subject to the highest temperature the microstructure consists of a mesh of ferrite around large grains of pearlite with many Widmanstätten ferrite needles. Such a microstructure has a low deformability and a low toughness and as such has a low fatigue strength.

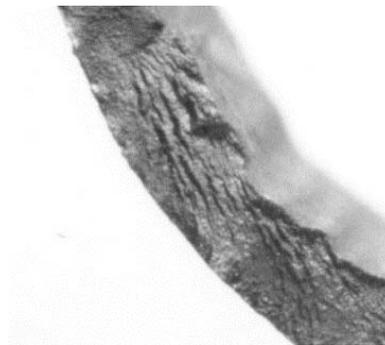
The ridges are parallel with the tube's circumference. This kind of surface morphology is typical of rapid crack propagation in steel without significant deformation. A cross-section of the tube was cut and prepared for

Figure 5: Ridges on the fracture surface
Slika 5: Brazde na površini preloma

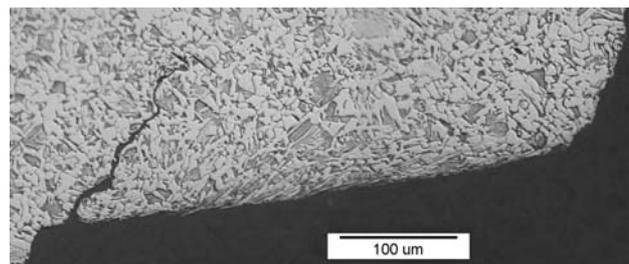
Figure 6: Crack on the fracture surface
Slika 6: Razpoka na površini preloma

metallographic examination. The crack in **Figure 6** shows transcrystal propagation typical for fatigue.

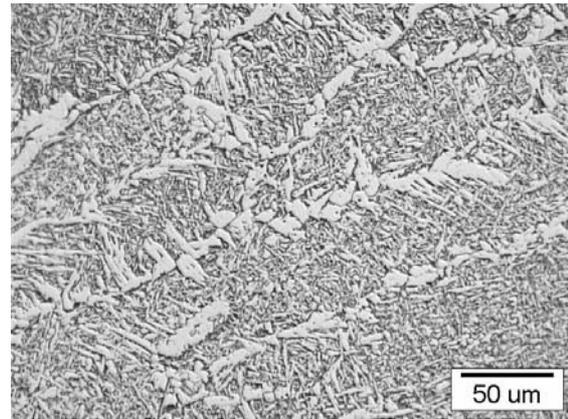
Figure 8: Microstructure of the fillet-weld deposit material
Slika 8: Mikrostruktura deponiranega materiala zvara

There is clear evidence of columnar crystals in the weld deposit metal. The microstructure consists of bainite with a small amount of ferrite in the grain boundaries after the transformation (**Figure 8**). The grains of austenite in the HAZ near the fusion line grew in size because of the overheating.

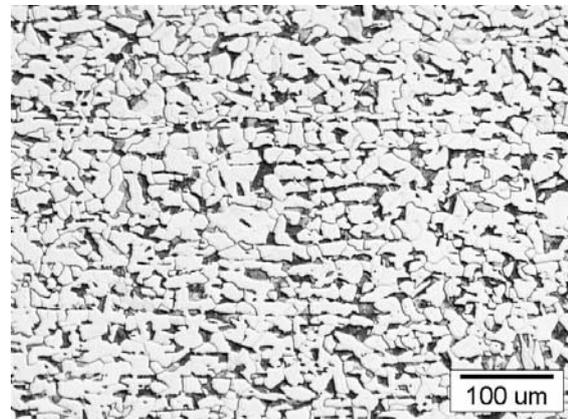
Figure 9: Microstructure of the tube's base metal
Slika 9: Mikrostruktura osnovnega materiala cevi

At the cooling cooling the austenite transformed into pearlite, bainite and a ferrite net. The microstructure of the base metal (**Figure 9**) consist of uniform grains of ferrite and pearlite. The wide HAZ indicates a very large input of heat during the welding.
