## AN AES INVESTIGATION OF BRUSHED AISI 304 STAINLESS STEEL AFTER CORROSION TESTING

**Matjaž Torkar, Djordje Mandrino, Martin Lamut**

Institute of Metals and Technology, Lepi pot 11, 1000 Ljubljana, Slovenia  
matjaz.torkar@imt.si

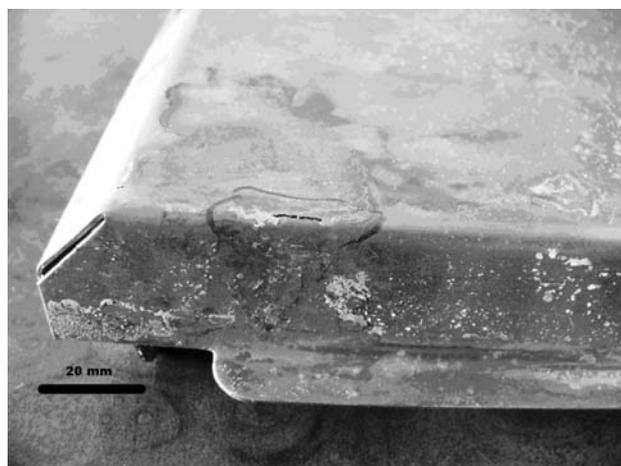
The rusty spots in **Figure 1** represent the remains of dried rust and were easily removed from the non-brushed surface. Most of the surface below the rusty spots was without any corrosion damage. The possible sources of rust were cut edges, holes for screws and deformed regions where the sheet was bent. It is also important not to neglect the remnants of other material that was in contact with the sheet, like for instance, fragments of the brush. It seems that a liquid, contaminated with rust, was spread over the sheet, and after drying the rust spots remained on the non-corroded steel surface.

**Figure 1:** Remains of rust and NaCl on the surface of AISI 304 stainless steel after a corrosion test in wet salt chamber. The longitudinal pit is present on the bent edge

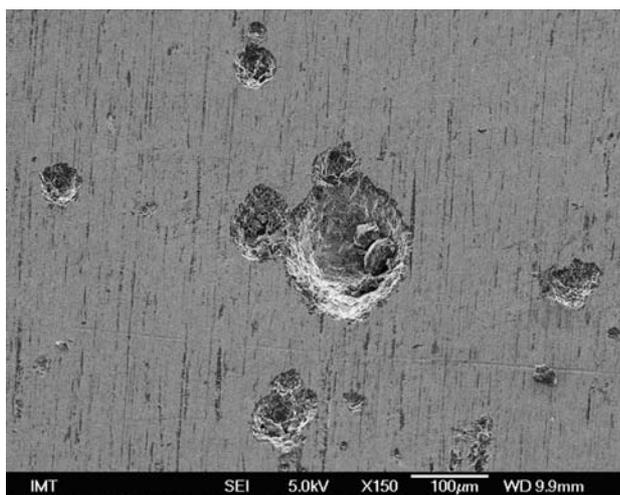
SEM microscopy of the brushed surface revealed individual corrosion pits and groups of corrosion pits (**Figure 2**). The longitudinal traces of brushing are evident on one side of the sheet, while the opposite side

**Figure 2:** Corrosion pits on the brushed surface after the corrosion test. SEM

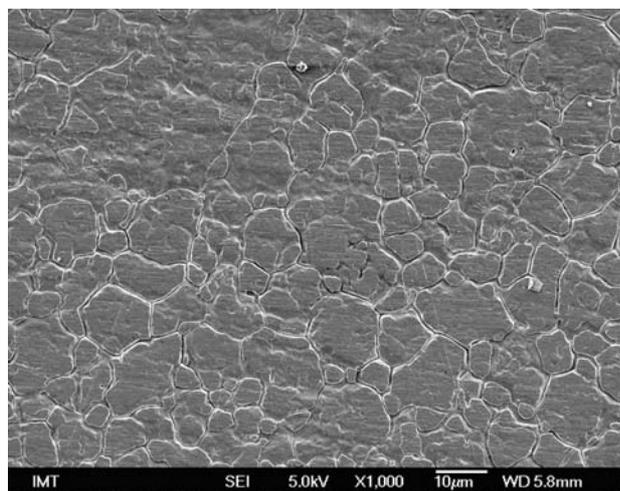
**Figure 3:** Untreated surface after the corrosion test. SEM

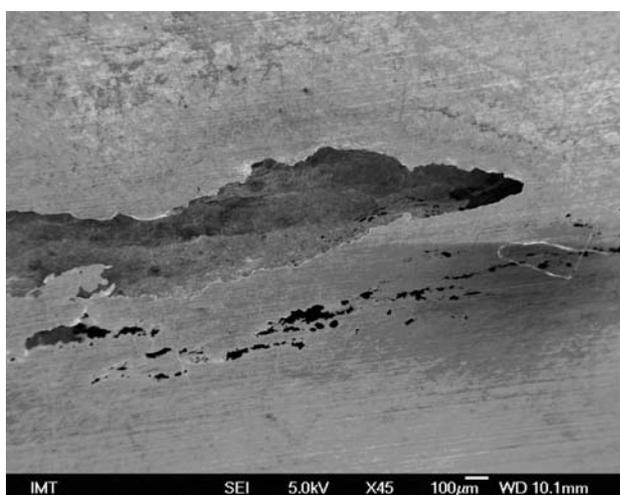
**Figure 4:** Longitudinal corrosion pit on the bent edge. SEM

of the sheet and the non-brushed surface revealed equiaxed grains with clearly defined grain boundaries (**Figure 3**). Only the brushed surface and the bent edge of the sheet were damaged by corrosion, and on the curved edge longitudinal pits were observed (**Figure 4**). In corrosion-damaged regions we observed either the aggregation of shallow pits or individual deep pits (**Figures 2 and 5**).

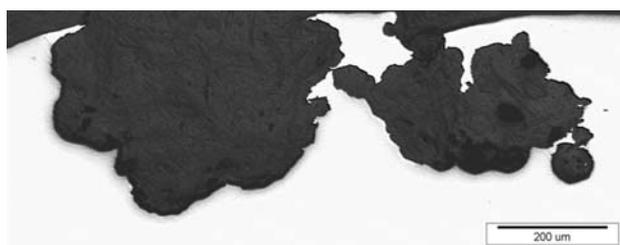
**Figure 5:** Micrograph of cross-section of the corrosion pit on the bent edge. Local corrosion advanced deep into the material of the case wall  
**Slika 5:** Posnetek preseka korozijske jamice na upognjenem robu. Lokalno je korozija prodrla globoko v material stene ohišja

Because of the wet environment and the presence of chloride ions in the salt chamber, the local pitting corrosion process started and advanced to the middle of the sheet, as revealed by the optical microscopy in the cross-section (**Figure 5**). The corrosion process was also accelerated by the presence of deformation-induced martensite. To transform the martensite into austenite, it is necessary to anneal the stainless steel after cold deformation.

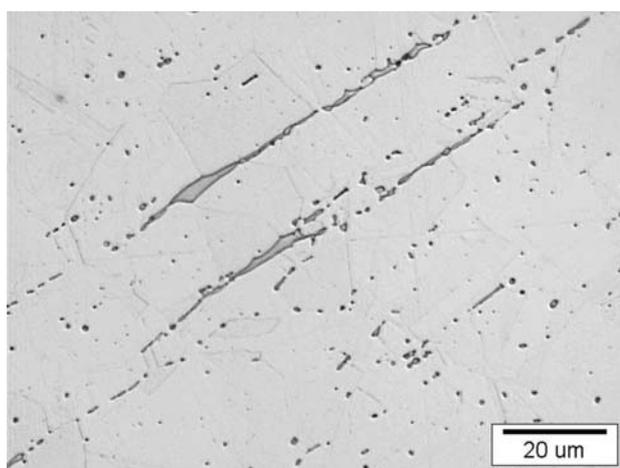
The metallography revealed martensite in the deformed regions in the austenitic matrix. Also, elongated delta ferrite (**Figure 6**) was present in the matrix. Both phases were a possible source of the corrosion, when in contact with the corrosion medium.

**Figure 6:** Microstructure of austenitic stainless steel AISI 304 with elongated delta ferrite. In deformed regions the deformation-induced martensite was also present. Etched with aqua regia.

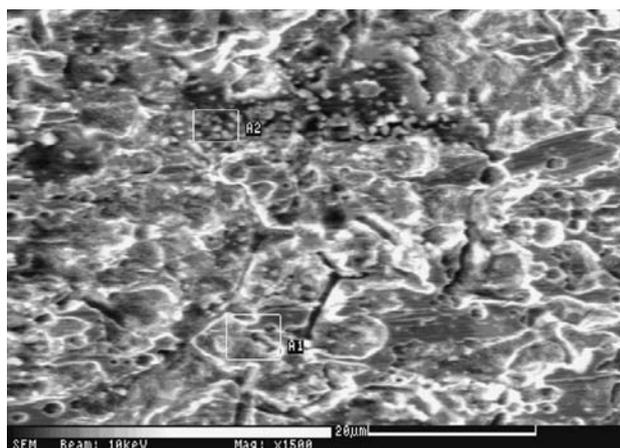
**Figure 7:** Surface damaged by corrosion (SEM). A1 and A2 mark the areas analysed with AES. Before the analyses the surface was ion etched for 45 minutes.

The AES analysis of the corroded steel surface (**Figures 7 and 9**) after the wet salt chamber test revealed that in the corrosion pits either sodium and chlorine or only chlorine were present (**Figure 8 and 10**). The binding energy of the analyzed element sodium corresponded to NaCl (**Figure 8**). The source of the NaCl was the wet salt chamber. No traces of sodium or chlorine were detected on the non-corroded surface (**Figure 10, P2**). But in typical use a possible source of chloride ions is from the environment (sprayed brine, the salt in food, cleaners).

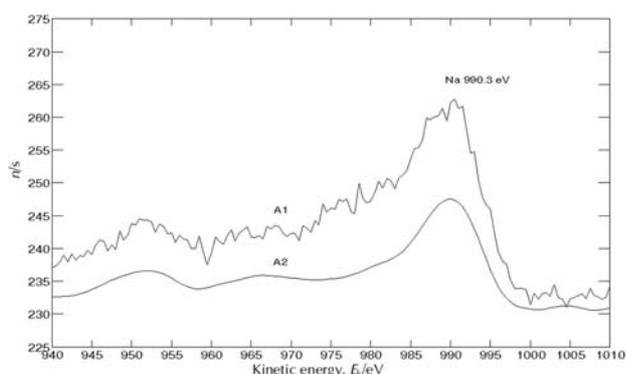
**Figure 8:** AES spectrum on the corroded places A1 and A2 marked in **Figure 7**. Presented peak for Na KLL at 990.3 eV in non-differentiated spectrum of AES corresponds to Na in NaCl<sup>9</sup>

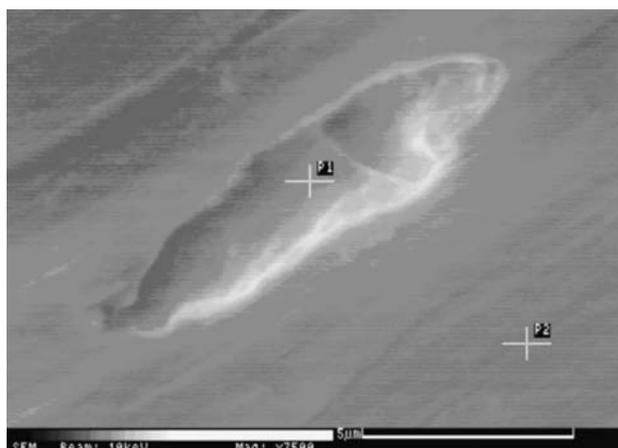
**Figure 9:** Surface with corrosion pit. At the points P1 and P2 the AES analyses were performed. The presence of Cl was detected only in the pit. SEM

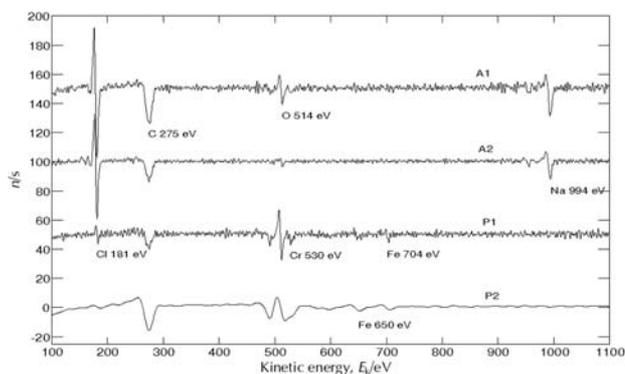
**Figure 10:** AES spectrum in the areas A1 and A2 (**Figure 7**), and at the points P1 and P2 (**Figure 9**) Only in the corroded areas A1 and A2 was the presence of Na and Cl detected. In the pit P1 only Cl was detected. Out of the pit no Na or Cl was detected.
