A METALLOGRAPHIC EXAMINATION OF A FRACTURED CONNECTING ROD

Roman Celin, Boris Arzenšek, Dimitrij Kmetič

Institute of Metals and Technology, Lepi pot 11, 1000 Ljubljana
roman.celin@imt.si

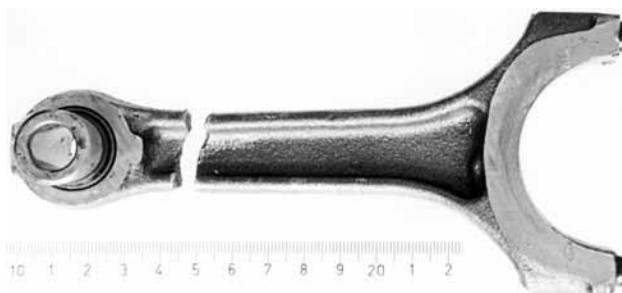
irreparable. There are many reasons for such a failure, e.g., the overheating of the engine, cracking, deficiency of the bearing lubrication, poor maintenance, etc. A catastrophic failure occurred for one of the four connecting rods of a 1.8-litre 16-valve internal combustion car engine while travelling at 100 km/h on a motorway. The side of the crank-case was ruptured and the corresponding piston was very deformed. Both parts of the fractured connecting rod are shown in **Figure 1**.

Figure 1: Connecting rod's fractured shank
Slika 1: Prelomljeno steblo ojnice

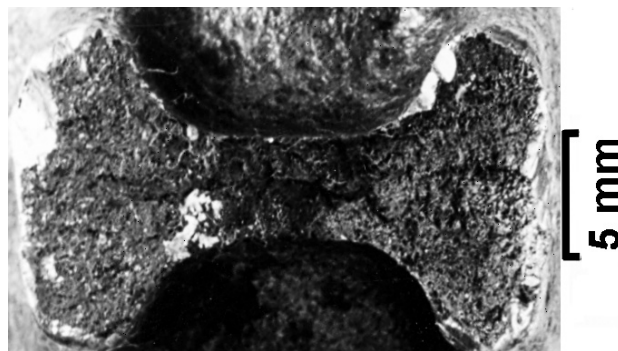
Figure 2: Fractured surface near the small end of the connecting rod's shank
Slika 2: Površina preloma na strani glave ojnice

near the fracture surface. The double-T cross-section of the shank's fractured surface is shown in **Figure 2**, and the rod's microstructure is shown in **Figure 3**.

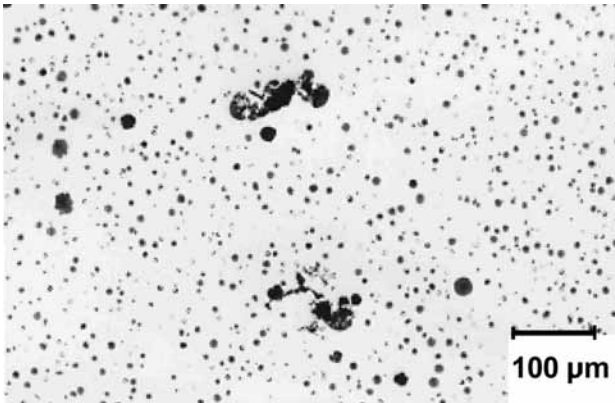
Figure 3: Specimen's microstructure (unetched)
Slika 3: Mikrostruktura vzorca ojnice (nejedkana)

The microstructure in **Figure 3** is typical for ductile iron (nodular graphite iron), with a fine lamellar pearlite matrix and small inserts of ferrite (approximately 5 %) around the graphite nodules (**Figure 4**).

According to the graphite classification, the microstructure in **Figure 3** corresponds to graphite form VI and graphite size 8 ³. The graphite nodules are small

(**Figure 3**), and this is evidence of an efficient process of nodulation with the probable addition of magnesium or cerium to the melt ⁴.

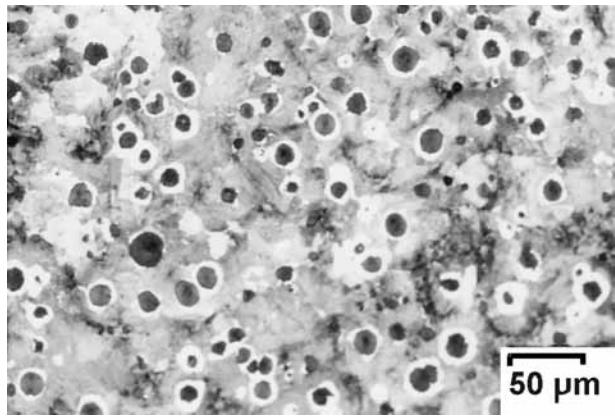
Figure 4: Specimen's microstructure (nital etched)
Slika 4: Mikrostruktura jedkanega vzorca (nital)

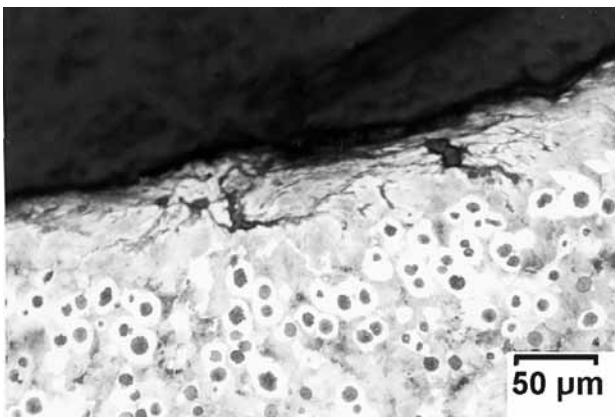
Figure 5: Casting defect on the surface of the connecting rod
Slika 5: Livarska napaka na površini ojnice

The whole surface of the connecting rod's two halves was examined carefully and numerous surface-casting defects were found. One of which is shown in **Figure 5**.

The surface of the connecting rod was sandblasted to increase the strength with strain hardening and to close the casting defects (**Figure 5**). The connecting rod supports a complex fatigue load, with repeated loading during every crankshaft revolution, and because of this loading, every casting defect has the potential to become the initial point for fatigue-crack initiation, where the local stress in the defect tip is increased because of the "notch effect". After an initial propagation, with each crack opening the crack advances by one striation, at a critical crack size the rupture occurs. On the investigated fracture surface the striations were not sufficiently clear to reliably determine the initiation point. The final fracture surface has marks of plastic straining and from their microscopic appearance it is concluded that the final fracture occurred with a very small plastic deformation preceding the opening of the crack. The final

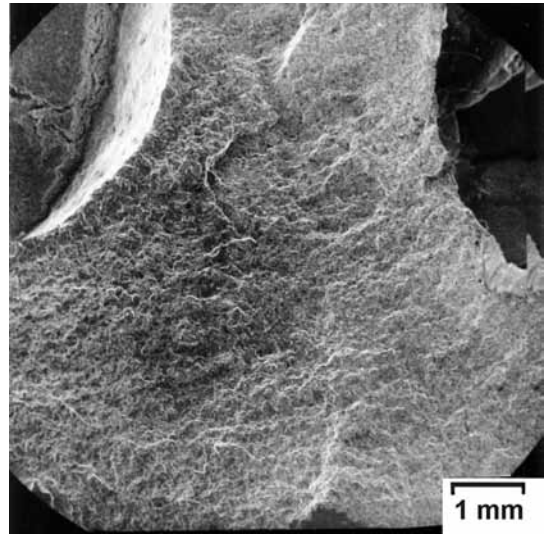
Figure 6: SEM image of the small-end fracture surface
Slika 6: SEM-posnetek preloma na strani glave ojnice

The fracture surface of the connecting rod was examined in the SEM, and the small-end fracture surface is shown in **Figure 6**.

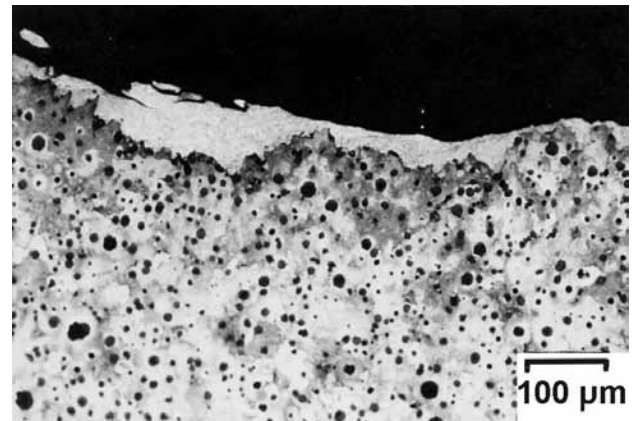
Figure 7: Residue of aluminium on the big-end fracture surface
Slika 7: Ostanki aluminija na površini preloma na strani noge ojnice

Figure 7 shows the microstructure of the big-end fracture surface. Residues of aluminium were found; a result of the connecting rod being pushed through the aluminium crank-case. The aluminium can be seen in **Figure 7** as structure on the edge of the fractured surface.

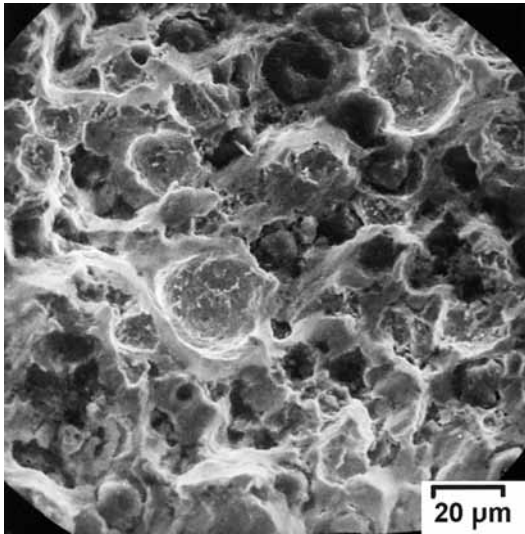
Figure 8: SEM image of small-end fracture surface
Slika 8: SEM-posnetek površine preloma pri glavi ojnice

The small end of the connecting rod's fracture surface was examined with the SEM. On the fracture surface there are numerous dimples with embedded graphite nodules or where the nodules had fallen out (**Figure 8**).
