INFLUENCE OF δ -FERRITE ON THE FATIGUE RESISTANCE OF BLADE MATERIALS

The low-pressure parts of a TG 1000 MW turbine, for the third wheels, are made from modified 12 % Cr martensitic steel AK1 TD.9, and the fourth, are made from X2CrNiMo13-4 steel. The fracture of the third turbine wheel at the point of the connection part of the blade has a high-cycle fatigue character with multiple initiation sites. An analysis of the microstructure has proved the influence of both the δ -ferrite content and the arrangement on the initiation point of the fatigue process. Also, an inspection of the fatigue crack's kinetics in relationship to the operating mode of the power plant has been carried out.

In October 2008 the blade of the third turbine wheel (3TW) placed on the third low-pressure part (3LP) of the TG1 broke. Consequently, the broken blade damaged the turbine wheels numbers 3 and 4 on the LP1, LP2 and LP3 (see **Figure 1**). The break in the blade occurred near the connection part (**Figure 2**) during the blade's operation. Cracks in the connection-part regions within the turbine wheels of other low-pressure parts were discovered with defectoscopic analysis. The damaged connection part

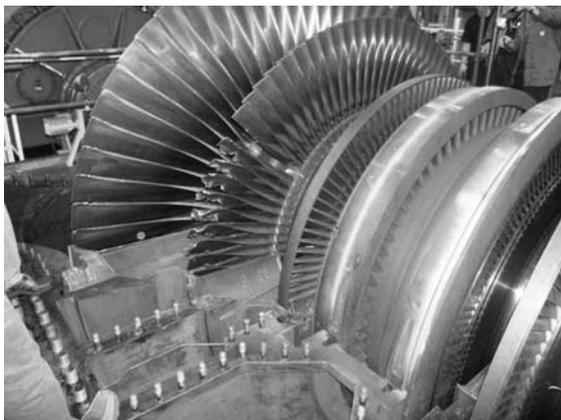
Figure 1: Damage to the 3TW on the TG1
Slika 1: Poškodba 3TW na TG 1

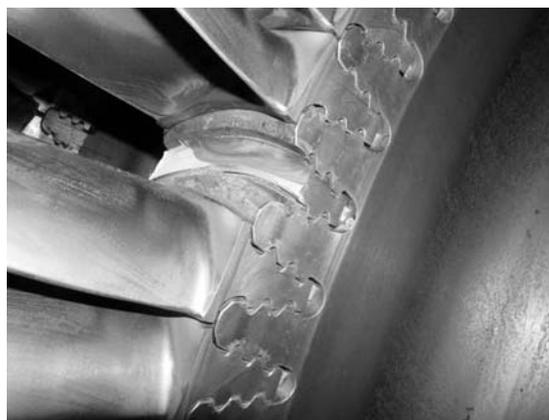
Figure 2: Damage to the connection part
Slika 2: Poškodba na mestu vpetja

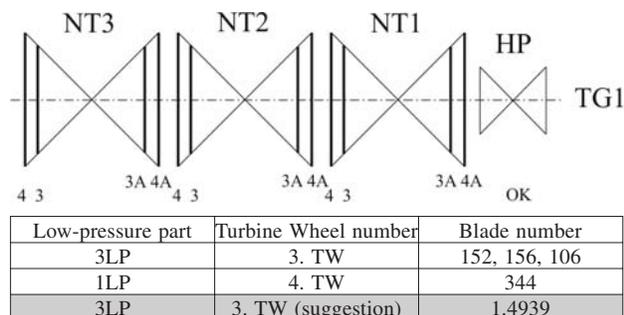
composition, mechanical properties, fractography and time-dependent estimation of the crack propagation of the removed blades were tested. The scheme of the damaged blades within the whole turbine vessel is shown in **Figure 3**.

Figure 3: Scheme of broken blades within the whole turbine vessel
Slika 3: Shema prelomljenih lopatic v turbinskem ohišju

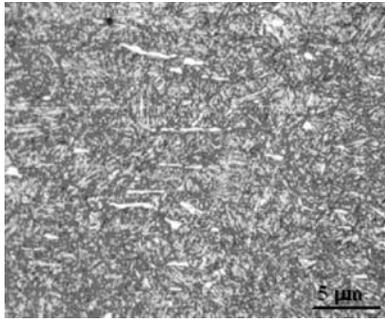
The microstructure of the base material was typical for modified 12 % Cr martensitic steel. The microstructure of the heat-treated (quenched and annealed) steel is shown in **Figure 4**. The large amount of δ -ferrite present in the microstructure was aligned in rows, oriented parallel with the initial crack growth and may have

Figure 4: Blade No. 152 (PN), 200x, microstructure of base steel
Slika 4: Lopatica št. 152 (PN), mikrostruktura osnovnega jekla (200-kratna povečava)

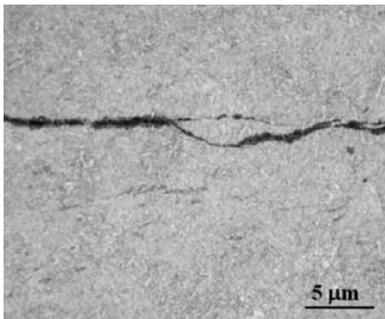
greatly influenced the propagation of the fatigue cracks (see **Figure 5**).

Figure 5: Blade No. 106, 200x, longitudinal crack and aligned inserts of δ -ferrite
Slika 5: Lopatica št. 106, podolžna razpoka in usmerjeni vložki δ -ferita (200-kratna povečava)

The initiation of the fatigue cracks was a result of the presence of δ -ferrite (modified 12 % Cr martensitic steel). The fractographical reconstruction revealed that the initiation of the fatigue cracks in the blades started quite early after the initialization of the working process.

From the microstructural analysis it was concluded that the presence of δ -ferrite (the shape and the particles) negatively influences the resistance of the modified 12 % Cr martensitic steel to crack initiation. The subsequent propagation of fatigue cracks is controlled by the main operating load. The new material, 1.4939, without tungsten, which eliminates the presence of δ -ferrite to a large extent, is proposed for the manufacture of 3.TW blades.

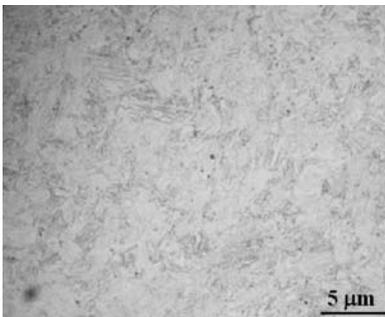
The microstructure of the base steel of X2CrNiMo13-4 consisted of sorbite, and was typical for the heat-treated (quenched and annealed) steel. No δ -ferrite inserts were found within the structure, even at a magnification of 400 (see **Figure 6**). The quantitative analysis of the amount of δ -ferrite is shown in **Figure 7**. The size of the original austenitic grains was evaluated according to the standards ČSN ISO 643 and ASTM E 112. A combination of Nital 3 % and Vilella-Bain

Figure 6: Blade No. 344 (PO), 200x, microstructure of base steel
Slika 6: Lopatica št. 344 (PO), mikrostruktura osnovnega jekla (200-kratna povečava)

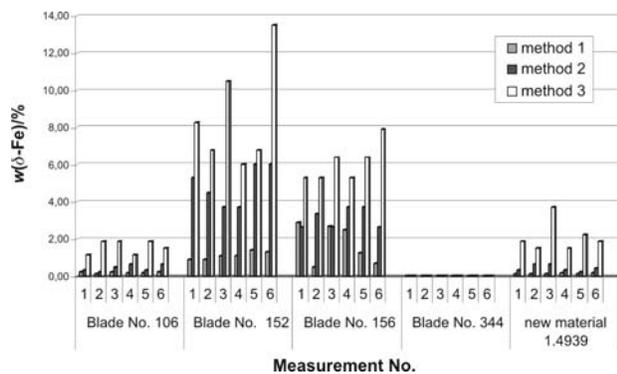
Figure 7: Content of δ -ferrite for different materials determined with different methods
Slika 7: Vsebnost δ -ferita v različnih jeklih, določena z različnimi metodami

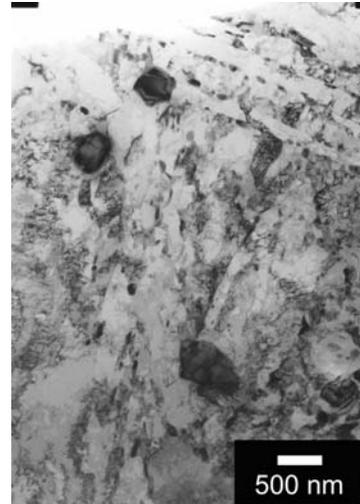
Figure 8: Blade No. 152, martensitic microstructure of base steel
Slika 8: Lopatica št. 152, martenzitna mikrostruktura osnovnega jekla

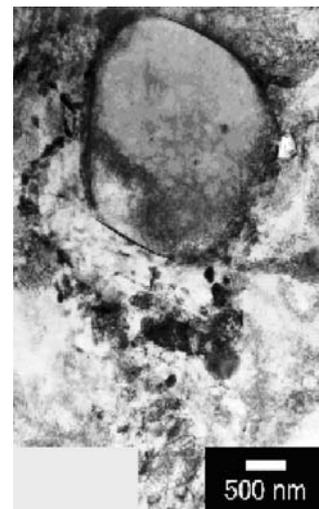
Figure 9 shows a grain of δ -ferrite in the modified 12 % Cr martensitic steel (**Figure 8**). The TEM revealed that the microstructure of blade No. 106 was similar to the microstructures of blades No. 152 and 156. Accord-

Figure 9: Blade No. 152, detail of δ -ferrite particle
Slika 9: Lopatica št. 152, detajl delca δ -ferita

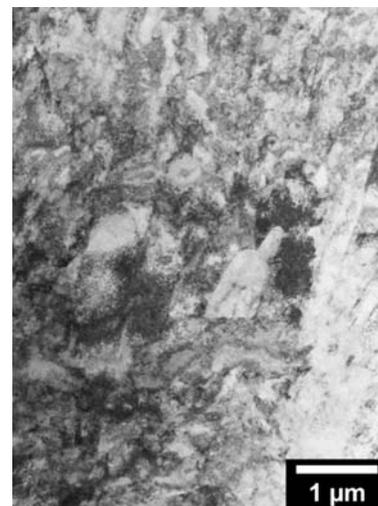
Figure 10: Blade No. 344, martensitic microstructure
Slika 10: Lopatica št. 344, martenzitna mikrostruktura

Blade No. 344 of the steel X2CrNiMo13-4 (**Figure 10**) contained very fine precipitates of the intermetallic phase Fe_2Mo (**Figure 11**). Similar fine particles were also found in the newly developed steel 1.4939, which was free of coarser particles typical for the other analysed steel. Nevertheless, the local occurrence of a very limited quantity of these carbide particles cannot be excluded.

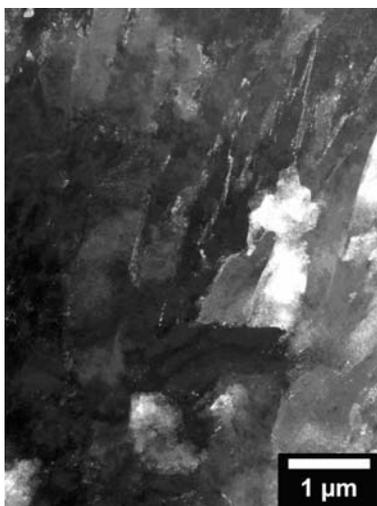
Figure 11: Blade No. 344, fine precipitates displayed in dark field
Slika 11: Lopatica št. 344, izločki, prikazani v temnem polju

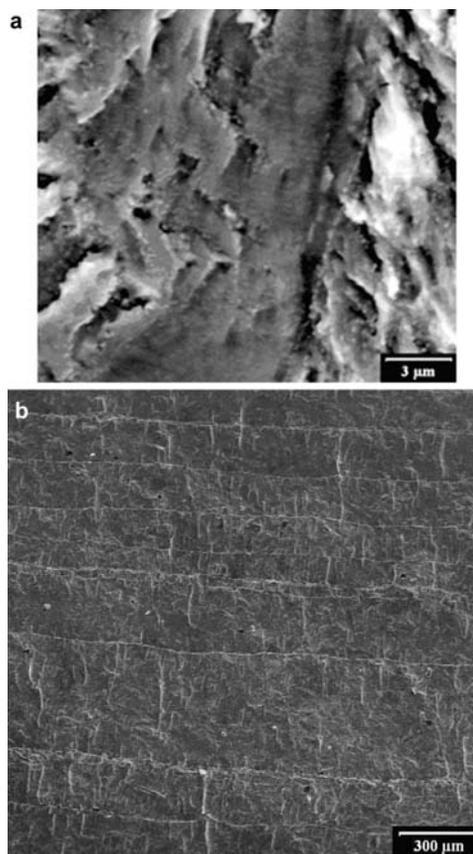
From the width of certain growth rings it can be concluded that during stable operating conditions the crack-propagation stopped. From the microfractography it can be further concluded that the fatigue failure propagated with the striation mechanism (see **Figure 13a**).

Figure 13: Characteristic microfractographical signs of fatigue failure. (a) Blade No. 152, field of submicron striations, (b) Blade No. 152, propagation lines

In addition, the presence of the progressing line determined the location and the shape of the fatigue crack tip at the moment of the overloading cycle. The dependence between these lines and the operating conditions made it possible to reconstruct the whole history of the failure process (see **Figure 13b**).

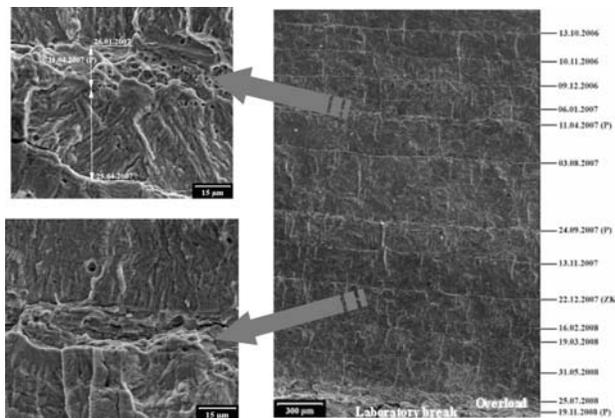
Figure 14: Blade No. 156. Propagation lines on the fracture area and dates of turbine operation

Figure 14 shows the propagation lines identified by these observations. These lines correspond to the data on the left-hand side of the micrograph. As mentioned above, the lines are related to the table operation of the turbine, and from the known data of the specific factory test the propagation regime on the fracture can be derived. The main results of the fatigue fraction history of the blades from 3.TW on LP3 in the fracture area can be seen in **Figure 15**.

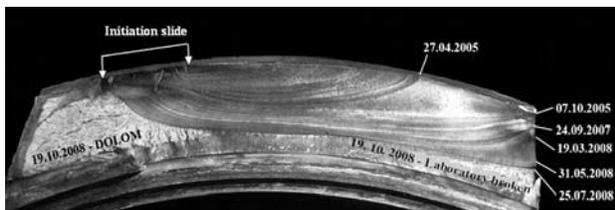
Figure 15: Blade No. 156. Dates, when the crack front reached the line of final blade failure
