MATERIAL FAILURE OF AN AISI 316L STAINLESS STEEL HIP PROSTHESIS

Matjaž Godec

Institute of Metals and Technology, Lepi pot 11, 1000 Ljubljana, Slovenia
matjaz.godec@imt.si

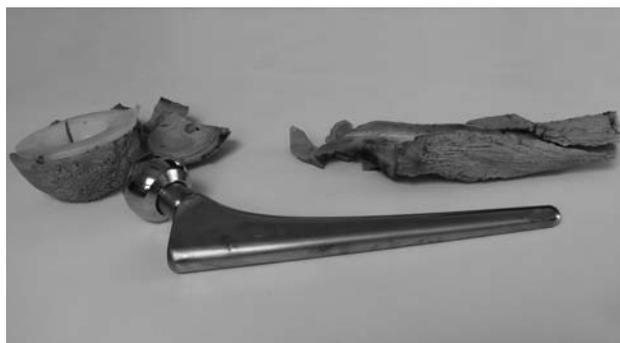
After stainless steel (AISI 316L) total hip prosthesis had been surgically replaced, it was microscopically and spectroscopically examined. Polyethylene acetabular cup as well as stainless steel stem were studied together with the cement binder in order to find out the cause of its loosening (**Figure 1**). Bone cement (PMMA) is an

Figure 1: Hip prosthesis together with acetabular cup and residues of cement after being surgery removed

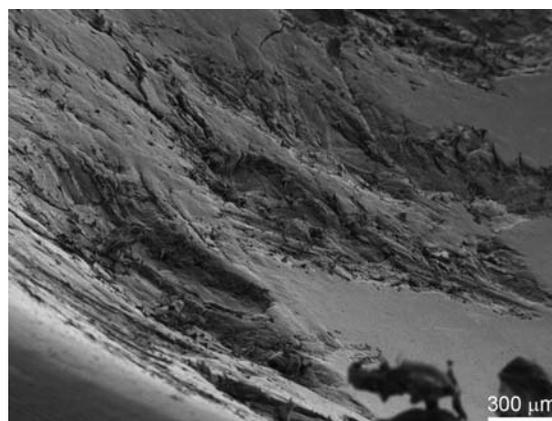
excellent type of fixation for the hip prostheses, especially for elderly, relatively inactive patients who are usually also suffering from osteoporosis. During patient movement the wear between the polyethylene acetabular cup and the metallic head caused formation of very fine, irregularly shaped and elongated particles not longer than 1 μm . Furthermore, tribological activity of the acetabular cup and the metallic head caused tearing of larger particles from the inner acetabular cup wall. It is supposed that in overload situations adhesion caused conditions that part of the acetabular cup can be pulled out. As a result, the polished surface of the inner wall of the polyethylene acetabular cup with 300 μm deep cavities randomly distributed was formed (**Figure 2**) and consecutively looseness the hip joint.

Figure 2: Surface modification of the polyethylene acetabular cup's inner wall with deep cavities, SE image

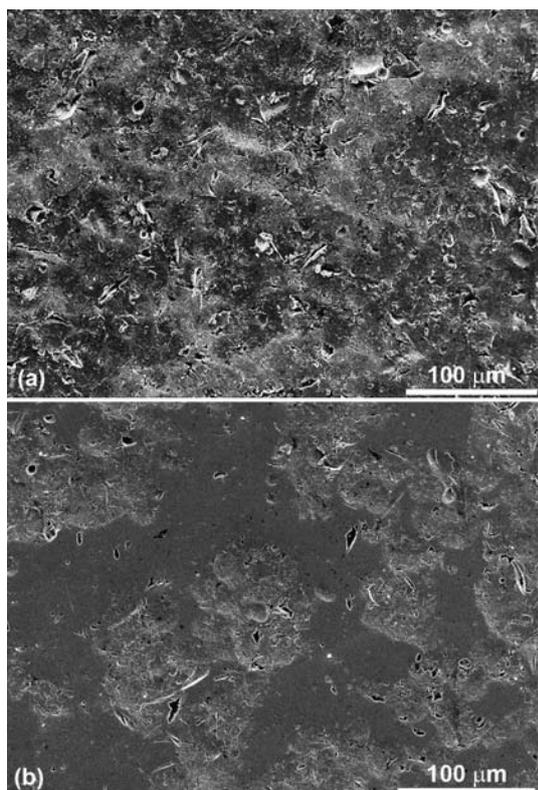
Figure 3: (a) Original sand blasted surface, SE image; (b) surface modification due to wear process, SE image

Analysed stainless steel stem indicated some of the surface areas not affected by wear while some parts of stem underwent significant changes due to wear process. **Figure 3 (a)** shows original sand blasted surface and **Figure 3(b)** demonstrated the surface which was

exposed to wear process. Rougher surface had plenty of small mechanically produced pits visible at a higher magnification. There were also plenty of Al_2O_3 particles embedded in the material most likely due to sand blasting procedure in order to make the surface rougher and easier for bone tissue to grow into. Al_2O_3 particles were detected by EDX in the stem surface (**Figure 4**).

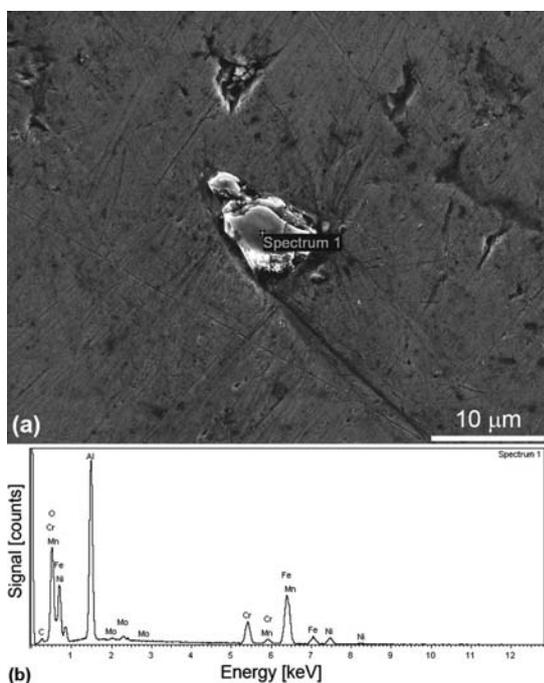
Figure 4: (a) SE image of alumina particle due to residue of surface sand blasting with marked spot of the EDX analysis; (b) EDX spot analysis of an alumina particle

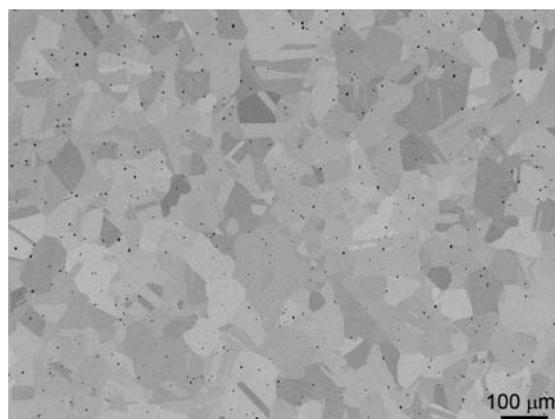
Figure 5: Microstructure of stem specimen showing plenty of Al_2O_3 non-metallic inclusions, BE image

Stainless steel stem microstructure across whole inner and outer part of implant had plenty of non-metallic inclusions (**Figure 5**). The inclusions were analysed by EDX. The inclusions were combinations of Al_2O_3 , SiO_2 and CaO particles and were consequences of problems during steel making. The presence of non-metallic oxide inclusions is a major cause of incompatibility between the attainable and desirable level of cleanliness in many grades of commercial steel. Generally, inclusions degrade the mechanical properties of the steel and thereby reduce the ductility of the cast metal and increase the risk for mechanical and/or corrosion failure of the final product. The number of these inclusions was too large for the AISI 316L steel grade particularly in an orthopaedic application. Oxide inclusions originate from two sources: (a) residual products resulting from intentionally added alloying elements to deoxidize the molten steel after oxygen treatment (endogenous or micro inclusions); (b) products resulting from reactions between the melt and atmosphere, slag, or refractory (exogenous or macro inclusions)³⁰. Alumina inclusions occur as deoxidation products in the aluminum-based desoxidation of steel. Most grades of steel are treated with calcium using Ca-Si alloy is certain amount of silicon is permitted in steel. During calcium treatment, the alumina and silica inclusions are converted to molten calcium aluminates and silicate which are globular in shape because of the surface tension effect. The change in inclusion composition and shape is known as the inclusion morphology control. However, such high amount of that type of inclusions is an evidence of wrong desoxidation process. The size of inclusions was from less than 1 μm and up to 5 μm . **Figures 6** and **7** show EDX spot analyses and mapping of such inclusions, respectively. There were some pure Al_2O_3 as well as pure SiO_2 , but most of them were combination of both with additional CaO content. During conventional metallographic sample preparation due to water presence a part of calcium inclusions might be lost. If calcium inclusions are of high interest of study the ion etching (cross-section polisher) or some similar techniques shall be used.

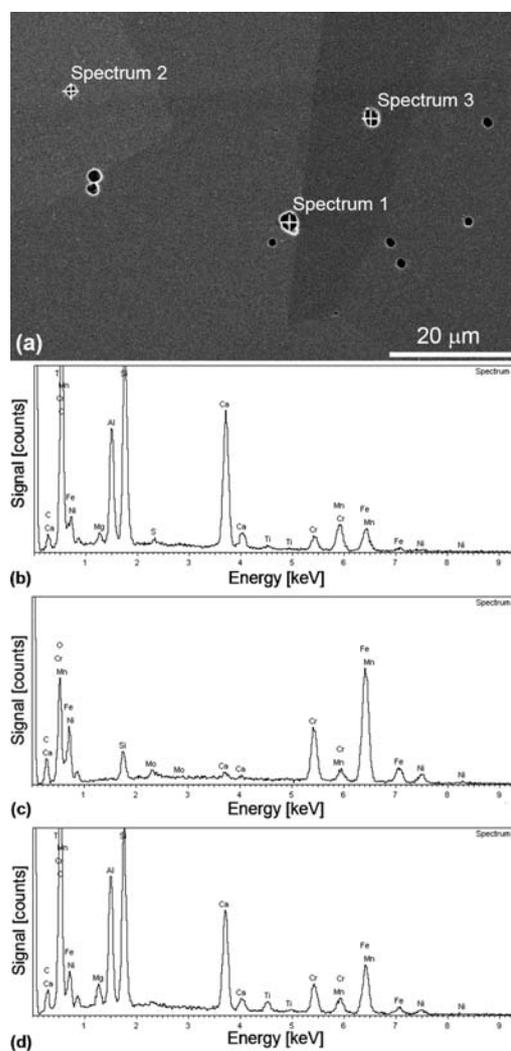
Figure 6: EDX spot analysis, (a) SE image of stem specimen with marked spots of EDX analysis, (b), (c) and (d) EDX spot analysis of non-metallic inclusions

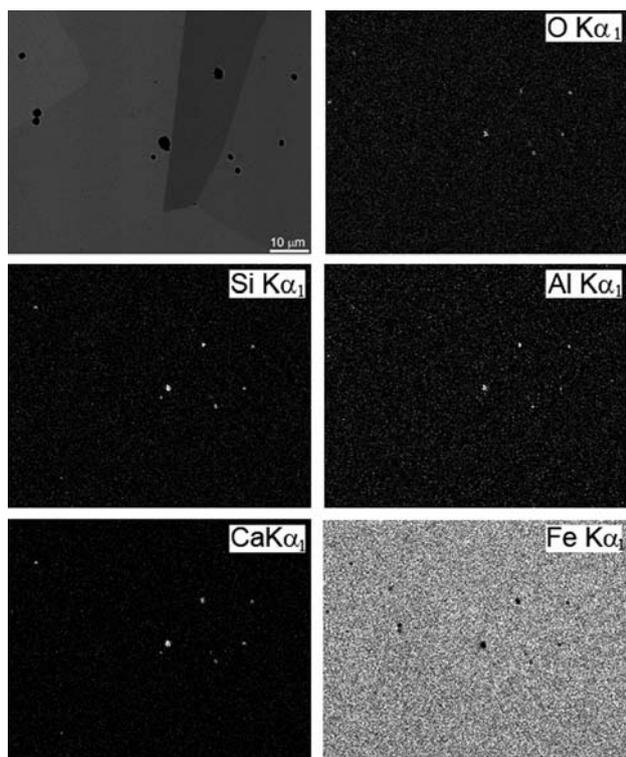
Figure 7: EDX mapping, (a) BE image of stem specimen with corresponding EDX images of (b) O $K\alpha_1$, (c) Si $K\alpha_1$ (d) Al $K\alpha_1$, Ca $K\alpha_1$ and Fe $K\alpha_1$

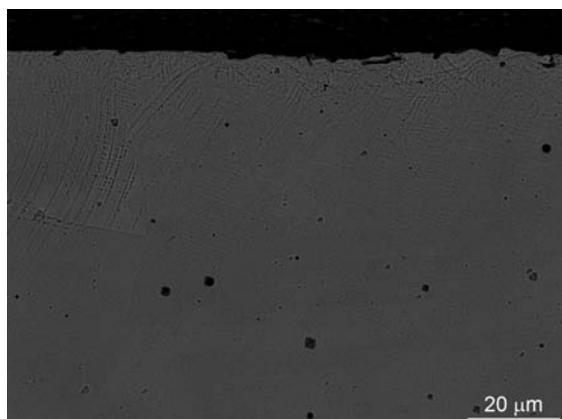
Figure 8: BE image of hip stem microstructure close to the surface with the slip lines due to surface deformation by sand-blasting

Stem microstructure consist of pure austenite phase. No other phases as delta ferrite, sigma phase and chi phase were observed and detected in the microstructure even though the specimens were etched or colloidal silica polished and observed by EBSD. Only in the very surface region in cross-section mode it was possible to observe slip lines caused by sand-blasting deformation (**Figure 8**). If deformation is enough high the defor-

mation martensite will take place. Such a microstructure is usually not desirable.

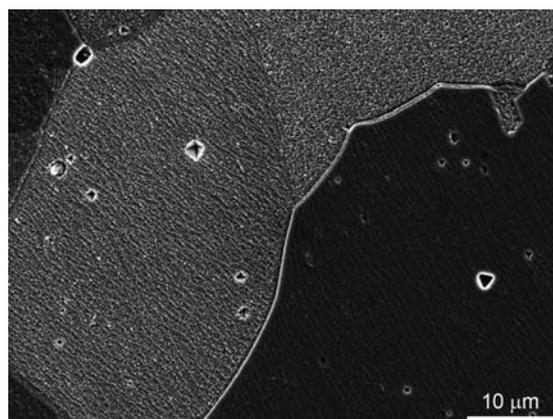
Figure 9: SE image of stem microstructure consist of austenite grains. Grain boundaries are free of any carbides and other phases. Etched by glyceric acid

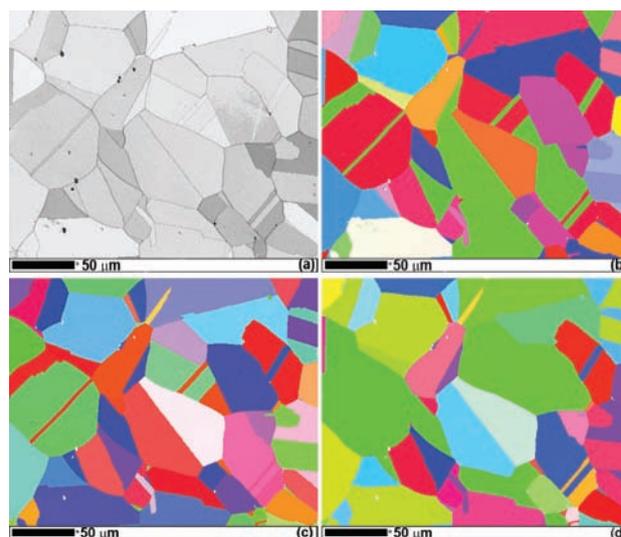
Figure 10: EBSD mapping (a) band contrast image (b) inverse pole figure in X direction, (c) inverse pole figure in Y direction, (d) inverse pole figure in Z direction
