CHARACTERIZATION OF DEFECTS IN PVD TiAlN HARD COATINGS

**Peter Gselman^{1,2}, Tonica Bončina², Franc Zupanič², Peter Panjan¹, Darja Kek Merl¹,
Miha Čekada¹**

¹Jožef Stefan Institute, Jamova cesta 39, SI-1000 Ljubljana, Slovenia

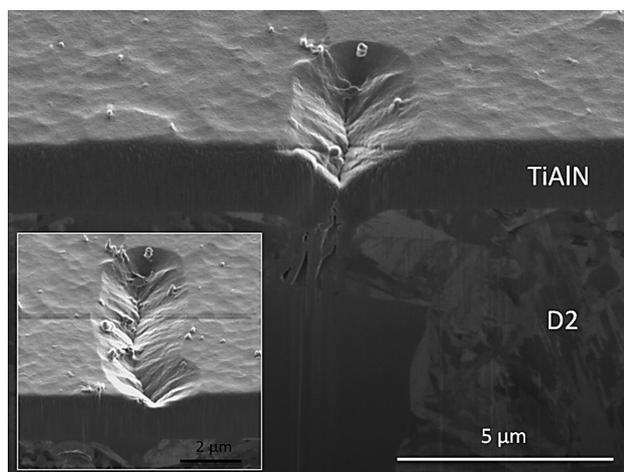
To reveal the problem we analyzed two typical defects. **Figure 1** shows a crater that was formed in the TiAlN coating on the D2 tool steel, while **Figure 2** displays a spherical droplet on the same substrate. From these two images it is difficult to conclude that corrosion

Figure 1: SEM image and FIB cross-sectional micrograph of the same growth defect (crater) on a sample TiAlN/D2 tool steel

took place, but when we continue with a series of slices, we can realize that the crater extends through the whole coating and originates in a small hole on the surface of the D2 tool steel (**Figure 1**). It is known that PVD processes have a poor ability to cover small pits or holes with a low aspect ratio (where depth is similar to their width) due to the shadowing effect.

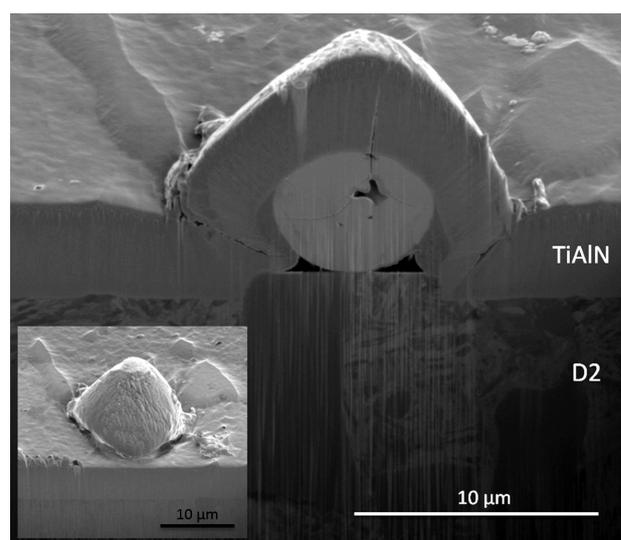
Figure 2: SEM-micrograph and an FIB cross-section image of a spherical droplet on a sample TiAlN/D2 tool steel

Spherical droplets (**Figure 2**) are created as a result of arcing. The arc tendency during the deposition or etching cycles is increased with impurities on substrates, shields, fixtures, turntables and targets. Arcs are the origin of microdroplet formation. Some of these microdroplets can be incorporated into the coating during its growth or deposit on the surface of the substrate.

In our case a microdroplet was deposited on the surface of the substrate material during etching or at the beginning of the deposition cycle (**Figure 2**). This conclusion can be confirmed by the fact that the droplet is in contact with the uncoated surface and that the substrate surface under the droplet is untreated by ion etching due to the shadowing effect (the step on the surface).

Figure 2 shows that the region under the spherical droplet is not completely filled with coating due to the shadowing effect. Unexpectedly, the corrosion did not occur under it. After a detailed FIB analysis we recognized that pitting corrosion did not appear because there were no pin holes or porosities that could allow the solution to penetrate into the substrate. However, it is necessary to point out that corrosion was found under the other examined spherical droplets due to the existing pin holes.

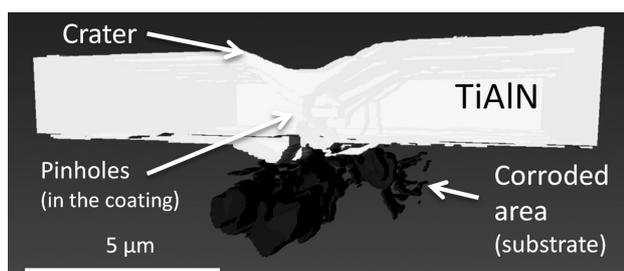
Figure 3: 3D reconstruction of a corrosion volume under a TiAlN coating on a site where a crater with pin holes was present

The 3D image clearly shows that under the crater a pin hole extends through the entire thickness of the coating (**Figure 3**). It is known that corrosion takes place on the spots, where the solution can directly reach the substrate. Black pits on the image represent the corroded volume of the substrate. The calculated volume of the corroded area is surprisingly large (around $23 \mu\text{m}^3$), while the volume of the crater is approximately two times smaller ($12 \mu\text{m}^3$). The corrosion products had a depth of $5 \mu\text{m}$ in the base material. On the spots where the corrosion has occurred, the substrate cannot provide

sufficient support to the coating, so it can be damaged easily.

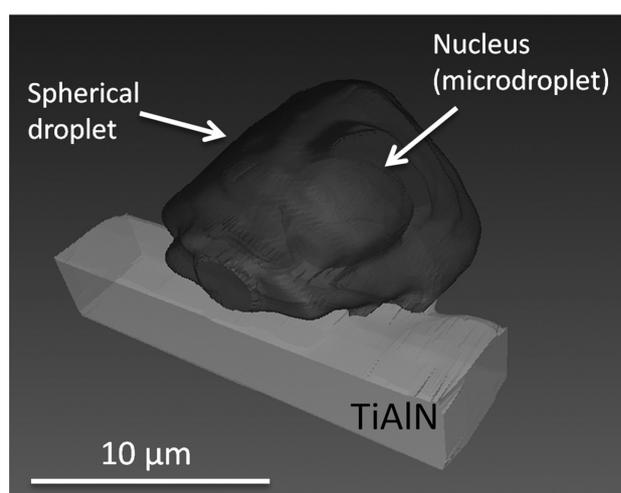
Figure 4: 3D-transparent image of a spherical droplet

A 3D rendering of a spherical droplet without a nucleus (microdroplet) is shown in **Figure 4**.
