CREVICE CORROSION OF STAINLESS-STEEL FASTENING COMPONENTS IN AN INDOOR MARINE-WATER BASIN

Matjaž Torkar, Franc Tehovnik, Matjaž Godec

Institute of Metals and Technology, Lepi pot 11, SI-1000 Ljubljana, Slovenia
matjaz.torkar@imt.si

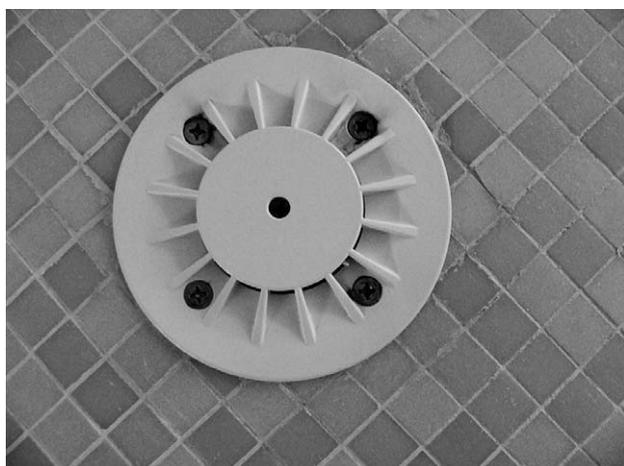
ily removable with a cloth. Corrosion pits were present on the steel surface under the rust. An in-situ control of all the basin components revealed rusted sites around the screws in the plastic inlets for fresh water (**Figure 1**), in the frames for the underwater lights and also on the joints connecting a step with a vertical holder tube (**Figure 2**). In fact, all stainless steel parts were more or less corroded.

Figure 1: Rusted cross-head screws at the bottom of the pool
Slika 1: Rjasti vijaki s križno glavo z dna bazena

The cross-head screw from the bottom of the basin did not contain molybdenum and was, thus, made of AISI 304 austenitic stainless steel that is less corrosion resistant in a chloride environment.

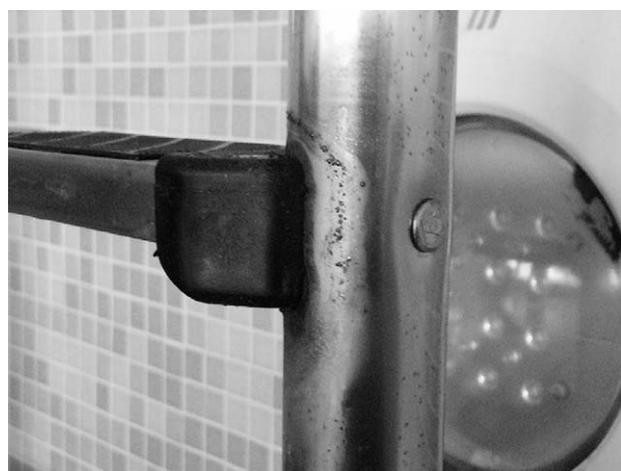
An individual stair was fixed with a plastic inlet and a bolt on the vertical stair-holder tube. The rust was spread around the bolted connection (**Figure 2**), while no rust was observed around the direct contact of a longer bolt and the step holder. The removal of the step showed that the rust originated in the joint of the spring washer and the nut. The rust was concentrated around the spring washer, below the nut and spread around the bolted joints. The spring washer was heavily corroded.

Figure 2: Rust on the vertical holder around the bolted-step connection
Slika 2: Rja na vertikalnem nosilcu okrog vijačenega spoja stopnice

For the bathers' safety sake, all the vital joint connections in the vertical stairs need to be checked periodically and, if necessary, replaced in time.

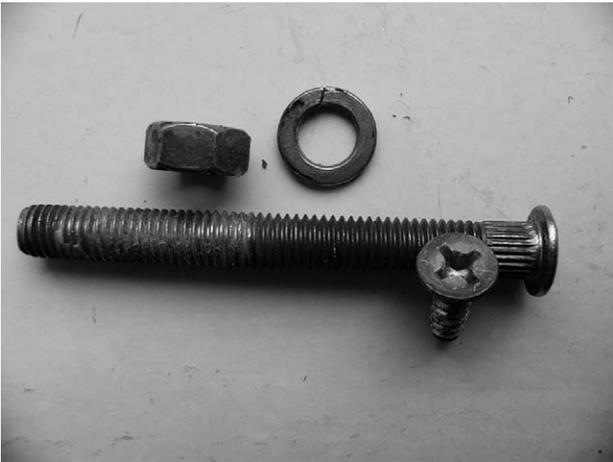
A photograph of the rusted nut, the washer and the cross-head screw was taken (**Figure 3**) before further cleaning and the rust was removed from all the investigated samples in an ultrasound bath (**Figure 4**).

Figure 3: A nut, a spring washer, a structural bolt of the stairs and a cross-head screw, all covered with rust

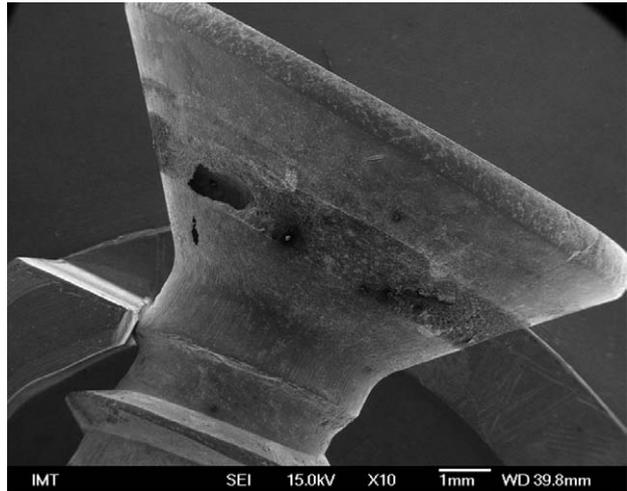
Figure 5: Screw damaged by crevice corrosion (SEM)

Inside the screw head we observed dip caverns (**Figure 5** and **6**) resulting from crevice corrosion. The basic conditions for the start of crevice corrosion are a wet environment with chlorides and a narrow crevice where a renewal of a damaged protective oxide layer on stainless steel is not possible due to the restricted oxygen diffusion in the crevice. Chloride ions from the salt water migrate into the crevice and increase the solution acidity accelerating the corrosion attack on the protective layer on the stainless-steel surface. The results of crevice corrosion are either deep corrosion caverns, as observed in

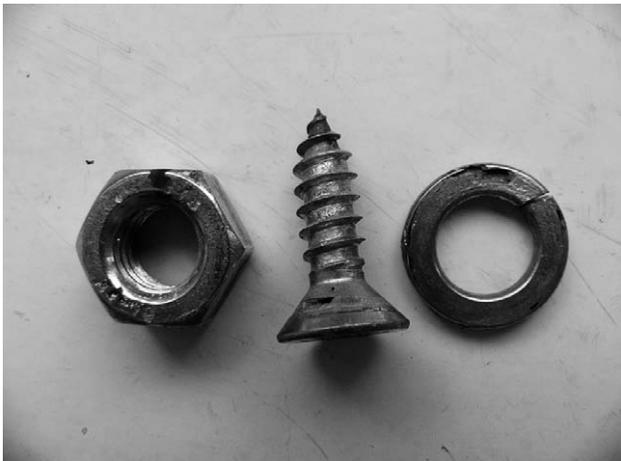
Figure 4: Corrosion-damaged structural components after cleaning with ultrasound

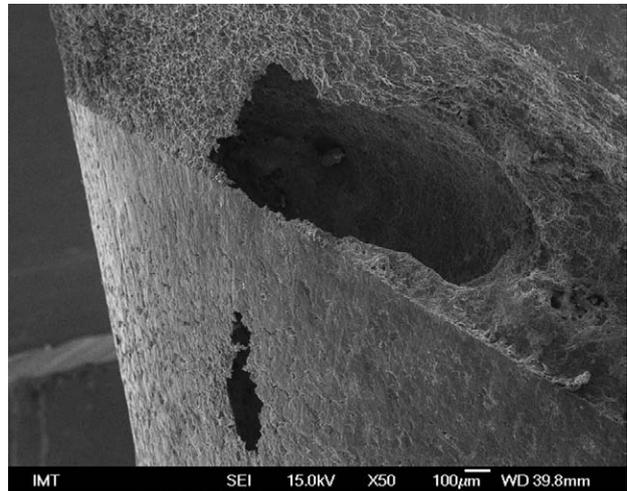
Figure 6: Detail from **Figure 5:** Crevice corrosion of a screw head (SEM)

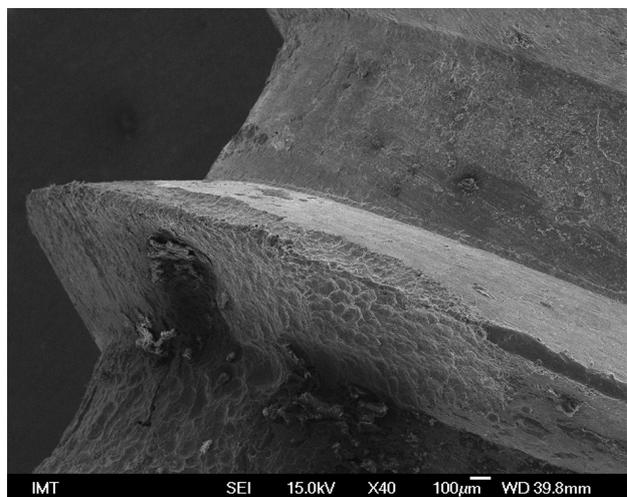
Figure 7: Corroded screw (SEM)

the screw head, or shallow pits, as observed on the screw body (**Figure 7**).

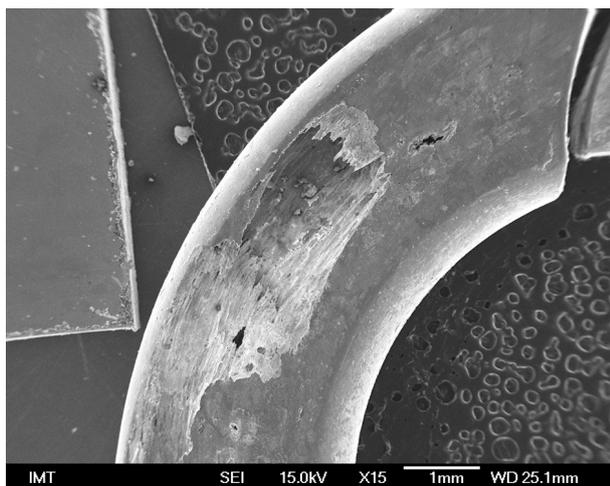
Figure 8: Crevice corrosion of a spring washer (SEM)
Slika 8: Špranjska korozija vzmetne podložke (SEM)

Corrosion caverns were also observed in the spring washer (**Figure 8, 9**), taken from the connection step of the vertical holder. A test of the spring washer with a magnet revealed slight magnetism in the cold-formed spring washer, probably due to the presence of deformation-induced martensite in the washer. This martensite in the austenitic stainless steel is magnetic and has a lower resistance to corrosion⁹. Deformation-induced martensite can be transformed back to austenite by heating at the temperature of 1 050 °C and by water rapid cooling. In the examined case, the spring washer was in the cold deformed state to keep the spring properties and for this reason the spring washer was the most sensitive component to corrosion. In general, there are two possible causes for the corrosion of a spring washer in a chloride environment: either crevice

corrosion^{10,11} due to geometrical reasons (the presence of a crevice) or stress corrosion¹² due to internal stresses in deformation-induced martensite of cold deformed steel. In the examined case it is supposed that the first cause prevailed because of the presence of corrosion caverns in the spring washer.

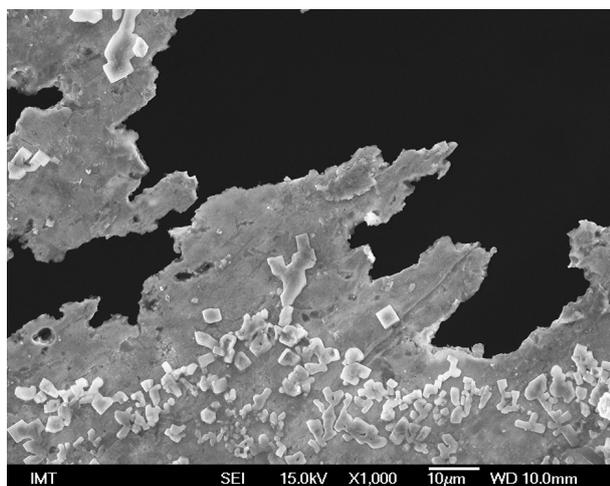
Figure 9: Remains of NaCl around a crevice-corrosion cavern (SEM)
Slika 9: Ostanke NaCl okrog izjede, povzročene s špranjsko korozijo (SEM)
