## COMPOSITES BASED ON INORGANIC MATRICES FOR EXTREME EXPOSURE CONDITIONS

**Amos Dufka, Tomáš Melichar**

Brno University of Technology, Faculty of Civil Engineering, Institute of Building Materials and Components, Veveří 95, 602 00 Brno, Czech Republic  
dufka.a@fce.vutbr.cz, melichar.t@fce.vutbr.cz

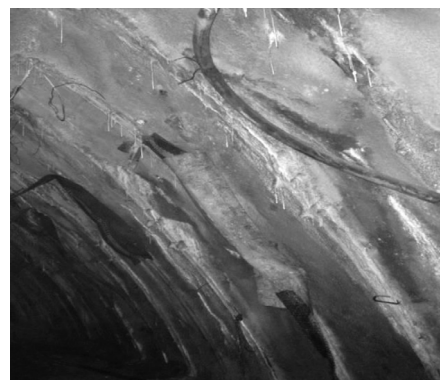
Already one year after the construction, significant defects began to occur. These were mainly the penetration of water through the lining, new formations of solid carbonate on the surface of the lining, the formation of waste products associated with the reinforcement corrosion, etc. A typical state of the damaged lining after one year of operation is shown in **Figures 1 and 2**.

**Figure 1:** View of the location, in which a massive penetration of moisture occurred: new solid-carbonate formations are visible on the surface of the lining

The state of the structure continued to deteriorate very quickly and, therefore, it was necessary to take corrective measures. It was found that before the construction of the collector no hydrogeological survey was performed, or it was performed unprofessionally and insufficiently.

On the basis of the results of the chemical analysis of the water samples it was possible to conclude that the water that passes through quaternary sediments does not cause the sulphate corrosion of the concrete. A completely different situation occurs when the water passes through tertiary sediments. These waters show moderate and, in some areas, even high sulphate aggressiveness. The results of the chemical analysis clearly demonstrated a high level of aggressiveness of the groundwater affecting the collector. Underestimating this fact or failing to carry out a hydrogeological research before the construction of a collector is, therefore, shown to be a serious deficiency.

Therefore, it was necessary to repair the structure. The first phase of the repair work related to the most affected areas. In these locations, the entire layer of the concrete along the lining was removed and the reinforcement affected by extreme corrosion was replaced. The removed concrete was then replaced with the repair material. Due to the highly aggressive environment, a mate-

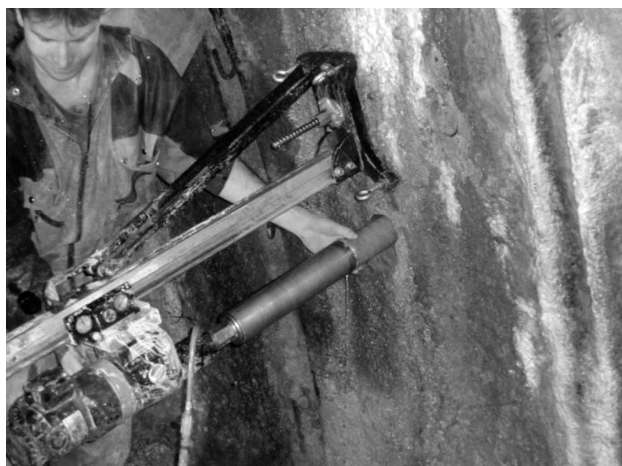
**Figure 2:** Collection of core bores from the lining. Significant carbonate efflorescence is visible on the surface of the wall.

It is clear that in certain locations, already after two years of the groundwater penetration, a massive degradation of the concrete occurred. The concrete's compressive strength in the affected areas is only about half of its original value. This finding corresponds completely with the results of the physical and chemical analyses showing massive corrosion formations (gypsum, secondary ettringite) in the microstructure of the affected concrete. In addition, the physical and chemical analyses showed that in some areas the water penetrating the lining caused quite an intense decomposition ("a washout") of the cement matrix. This, of course, resulted in a decrease in the strength of the concrete.

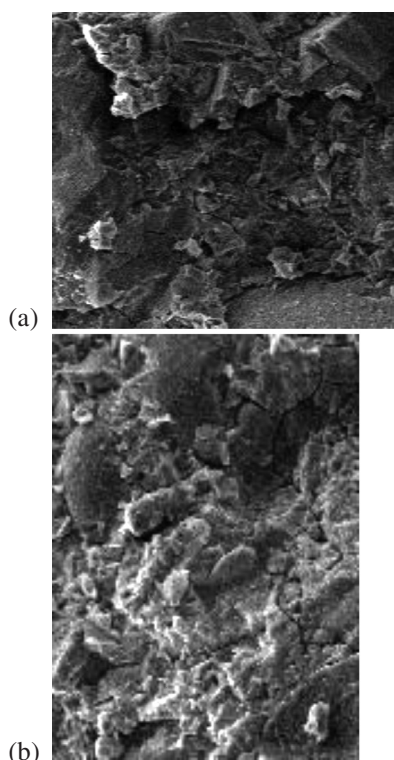
The microstructure of the material was also analysed using the scanning electron microscopy (**Figure 3**).

On the basis of the above findings we can say that in terms of both the strength parameters and mineralogy, the parameters of the repair material exposed to the highly corrosive environment are quite comparable with the reference parameters.

**Figure 3:** Detailed analysis of the microstructure showed a: a) de-facto amorphous phase of the matrix for both the reference material and b) the exposed material of the collector
