DEGRADATION OF AN AISI 304 STAINLESS-STEEL TANK

Matjaž Torkar, Irena Paulin, Bojan Podgornik

Institute of Metals and Technology, Lepi pot 11, 1000 Ljubljana, Slovenia
matjaz.torkar@imt.si

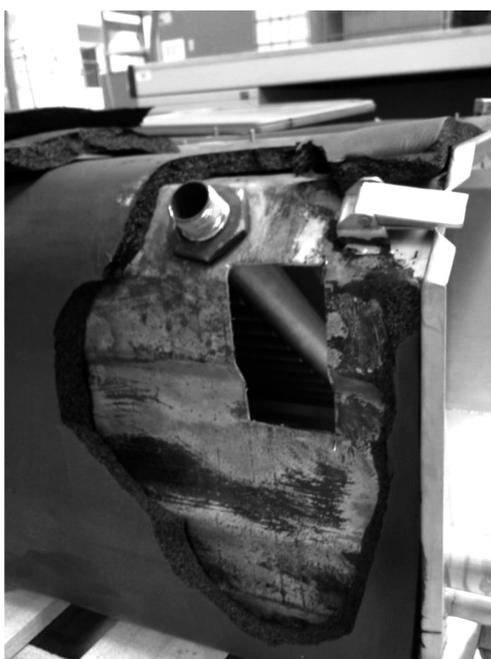
Figure 1: Corroded outer surface below the insulation
Slika 1: Korodirana zunanja površina rezervoarja pod izolacijo

The corroded areas inside and outside the tank under the insulation are shown in **Figure 1** and **Figure 2**. Inside the tank the corrosion damage is limited to the area shown in **Figure 2**, while the corroded area on the outside surface below the insulation is spread much wider (**Figure 1**) and looks more uniform. In addition, the place where the sample material was cut from the tank wall is presented in **Figure 1**.

For the investigated tank the corrosion process could be prevented by good contact between the insulation and the wall. This would prevent the formation of condensed water on the surface of the tank from the trapped moisture in the gap.

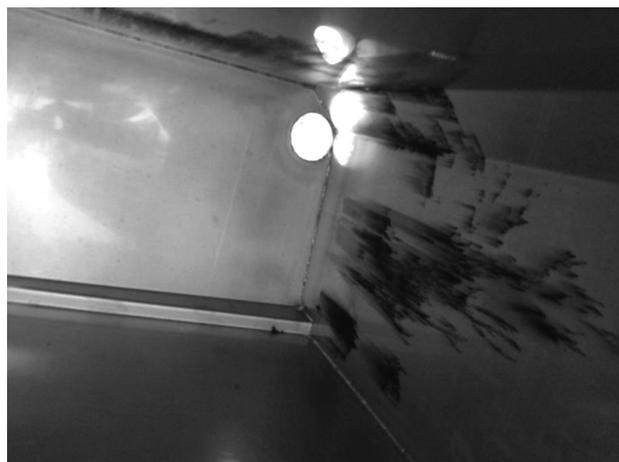
Figure 2: Local corrosion damage inside the tank
Slika 2: Lokalne korozijske poškodbe znotraj rezervoarja

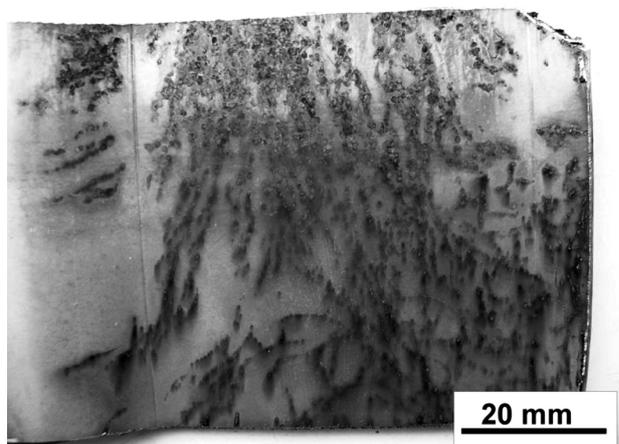
Inner surface of the tank, shown in **Figure 3**, looks like a general pitting-corrosion attack with some pits joining together to form interconnected pits.

Figure 3: Corrosion damage on the inner surface of the tank
Slika 3: Korozijske poškodbe na notranji površini rezervoarja

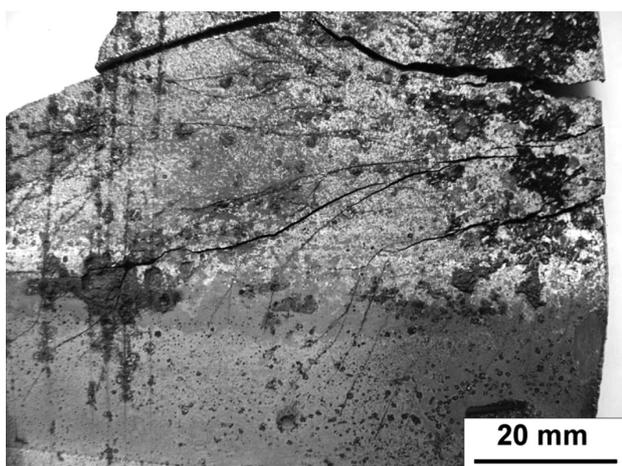
Figure 4: Corroded external surface of the tank with corrosion pits and cracks

Figure 4 depicts the sample material cut from the tank wall. Corrosion pits due to crevice corrosion and cracks due to stress corrosion are present on the outer surface of the tank.

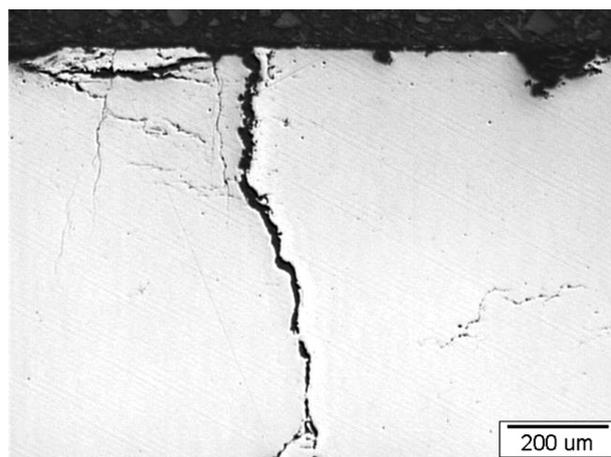
Figure 6: Cross-section of the tank wall

The cross-section of the degradation area, below the tank insulation, is presented in **Figure 6**. The crack originates from the crevice corrosion on the external surface of the tank.

The cracks (**Figures 6** and **8**) are typical for SCC and spread through the wall, mostly across the grains (trans-crystalline). Through the wall the cracks caused the leakage of the liquid stored in the tank. The cracks are connected with the pits and the pits act as initiation

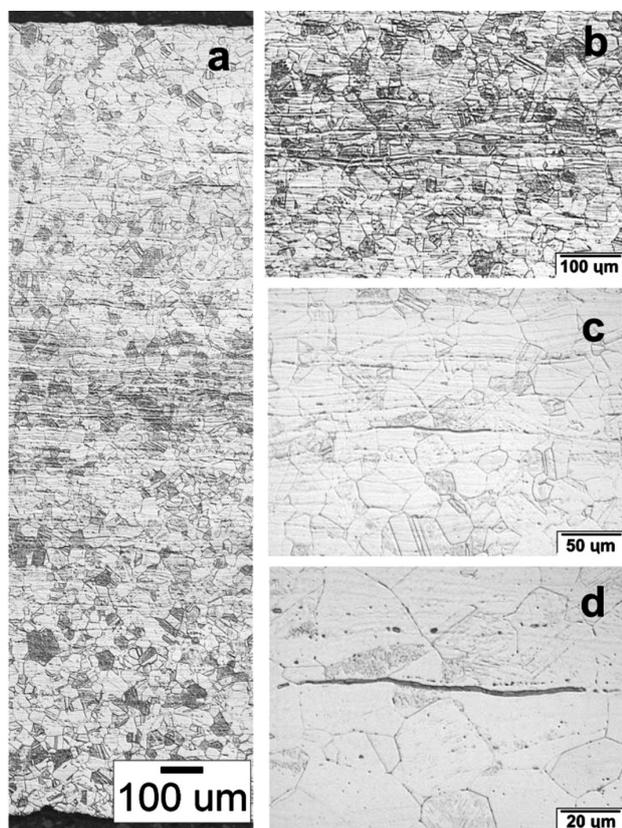
Figure 5: Microstructure of the cross-section of the wall

The microstructure of the cross-section in the sound part of the material is presented in **Figure 5a**. In the central part (**Figure 5b**) are the elongated grains. The elongated inclusions of MnS are shown in **Figures 5c** and **5d**, both oriented in the cold-rolling direction.

One possible reason for SCC of the tank is the longitudinal orientation of the crystal grains due to cold rolling of the sheet (**Figure 5**). The directed microstructure is evidence that the material was not properly recrystallization annealed after the cold rolling, and thus

the internal stresses remained in the material. This was also confirmed with cracks in the longitudinal direction following the longitudinally deformed crystal grains.

The elimination of internal stresses and the stabilization of austenite is possible in austenitic stainless steel with annealing to a temperature of 1050 °C, followed by rapid cooling in water. Such measures also prevent the formation of brittle phases in the steel, typical for a slow cooling process.

- selection of a more resistant material,
- elimination of internal stresses with material annealing,
- elimination of chloride ions in the storage liquid.

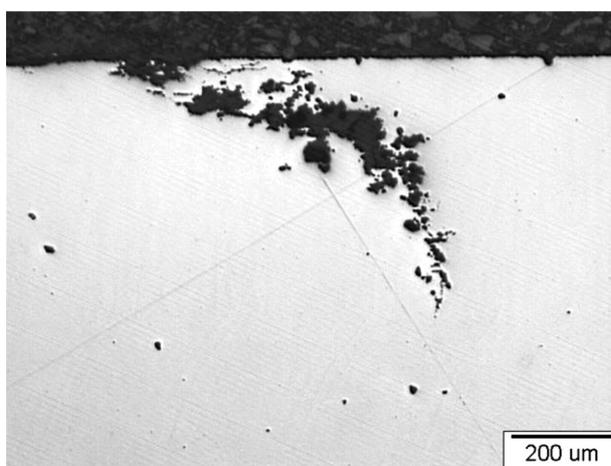
Figure 7: Crevice-corrosion pit

The presence of condensed moisture in the gap between the insulation and the tank's external surface caused the development of a crevice-corrosion pit shown in **Figure 7**.

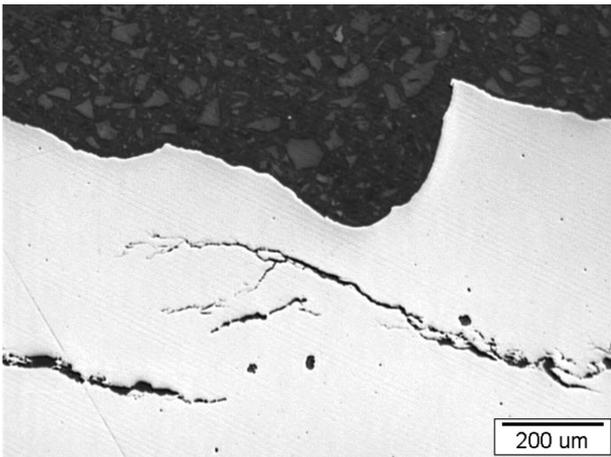
Figure 8: Internal surface pitting corrosion stress corrosion cracks
Slika 8: Jamičasta korozija na notranji površini rezervoarja in napetostne korozijske razpoke

places for the cracks' formation. We can conclude that the corrosion processes started as crevice corrosion on the external surface below the insulation.

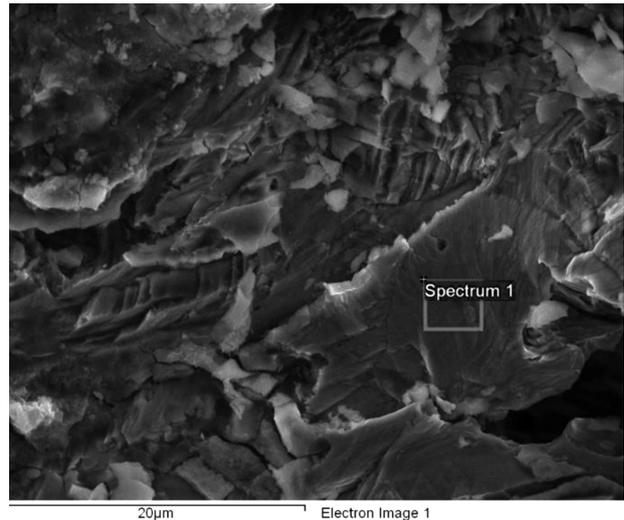
Figure 10: Brittle fracture of the wall
Slika 10: Krhek prelom stene

The brittleness of the material was observed only in the areas damaged by corrosion. The fracture of the wall is brittle (**Figure 10**) and typical for the SCC of stainless steel. The region of the EDS analysis (SEM) is marked as Spectrum 1.

The EDS analysis of the fracture surface (**Table 2**) detected the presence of chlorine, which is a regular companion in the corrosion of stainless steels and acts as the main accelerator of the pitting corrosion.

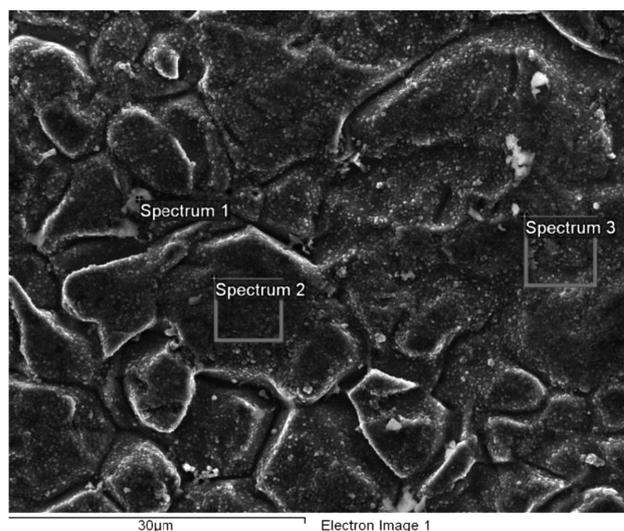
Figure 11: Surface with deep-etched grain boundaries and corrosion products with marked areas of EDS analysis (SEM)
Slika 11: Površina z globoko jedkanimi mejami med zrn in korozijski produkti z označenimi področji EDS-analize (SEM)

The deep-etched grain boundaries presented in **Figure 11** are due to the pickling of the sheet's surface. The surface is partially covered with corrosion products. The EDS analysis (**Table 3**) of the grain (Spectrum 1) revealed an increased content of oxygen, silicon, chlorine, manganese and nickel. On the other two areas analysed (Spectrum 2 and 3) traces of rust prevailed with contents of iron, chromium, nickel and oxygen. The origin of the chlorine is not known. This chlorine was detected on the corroded external surface as well as on the surfaces of the brittle cracks.
