EFFECTS OF VARIATIONS IN ALLOY CONTENT AND MACHINING PARAMETERS ON THE STRENGTH OF THE INTERMETALLIC BONDING BETWEEN A DIESEL PISTON AND A RING CARRIER

Ahu Fahriye Acar¹, Fahrettin Ozturk², Mustafa Bayrak²

¹Mopisan Piston Liner Ring Factory, Konya, Turkey

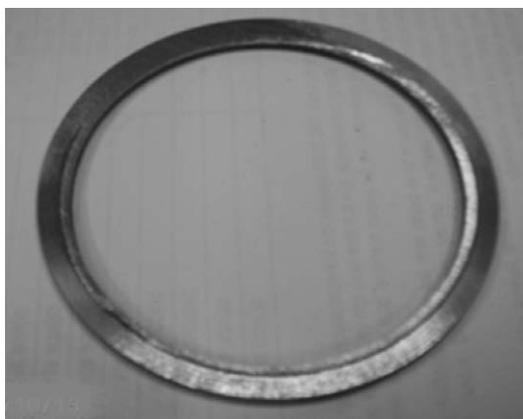
Figure 1: Non-defective ring carrier
Slika 1: Nosilec obročka brez napake

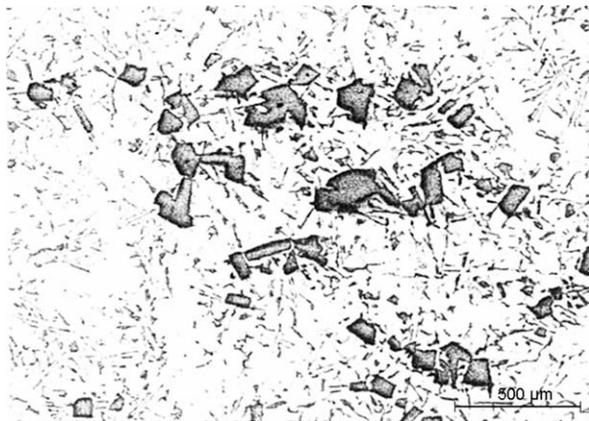
Figure 4: Microstructure of ring carrier (Inhomogeneous Si thinning) (100X)

The strength of the intermetallic bonding is related to the bonding quality. **Figure 2** shows the microstructure of the ring carrier. The left side of the dark boundary belongs to the Niresist ring carrier material; the right side shows the Al alloy piston's microstructure. The middle dark region displays the debonding area. Various other structures are presented in **Figure 3–5**. **Figure 3 and 4** show insufficient and inhomogeneous Si thinning,

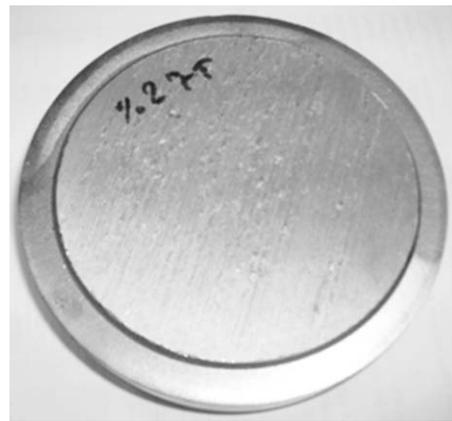
Figure 6: Defective ring carrier
