# SELECTION OF THE MOST APPROPRIATE WELDING TECHNOLOGY FOR HARDFACING OF BUCKET TEETH

**Vukić Lazić<sup>1</sup>, Aleksandar Sedmak<sup>2</sup>, Ružica R. Nikolić<sup>1</sup>, Milan Mutavdžić<sup>3</sup>,  
Srbislav Aleksandrović<sup>1</sup>, Božidar Krstić<sup>1</sup>, Dragan Milosavljević<sup>1</sup>**

<sup>1</sup>University of Kragujevac, Faculty of Engineering, Sestre Janjić 6, 34000 Kragujevac, Serbia

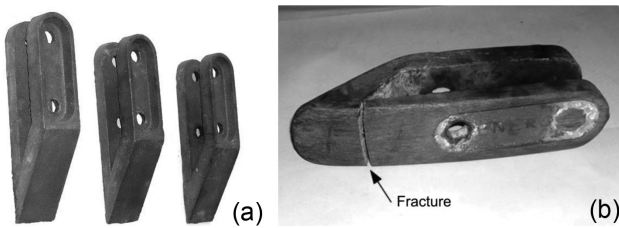
**Figure 1:** Loader bucket teeth: a) new parts, b) damaged part  
**Slika 1:** Zobje zajemalke: a) novi deli, b) poškodovani del

The role of bucket teeth (**Figure 1a**) is to separate and crush stone material and to protect the bucket against wear. The number and shape of teeth depends on the application (trench digging, gravel digging, material loading, etc.) and the size of the bucket, varying from three (trencher buckets) to fifteen teeth (buckets of bigger loaders). They can be installed in two ways: bolted directly to a bucket or their holder can be welded to a bucket and the teeth are bolted onto the holder. Teeth are made of cast steel or cast iron; their mass ranges from 3 kg to 15 kg per piece.

Two problems were noticed during the operation of the bucket teeth: the tougher and less hard teeth are subjected to plastic deformation and intensive wear, while the teeth made of brittle materials of high hardness break at higher impact loads (**Figure 1b**). A special problem is encountered with the construction machines operating in quarries or open-pit mines of ore and coal, where a piece of a broken tooth can get into the crushers and cause damage. Broken bucket teeth can also get into the equipment used for asphalt and concrete production and cause major damage and downtime.

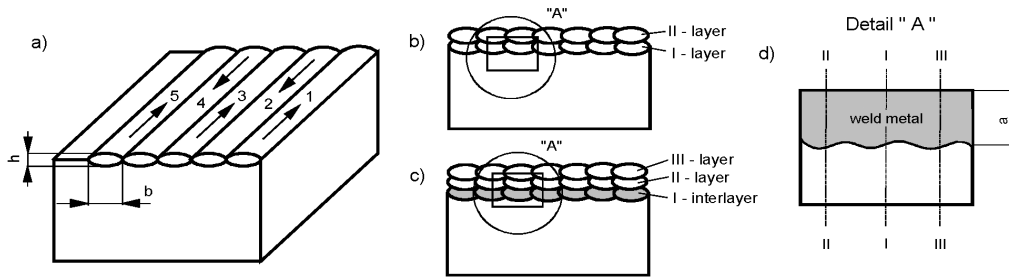
Figure 2: Order of hardfaced-layer deposition: a) 1<sup>st</sup> layer, b) 2<sup>nd</sup> layer, c) 3<sup>rd</sup> layer, d) metallographic sample (block)

The aim of these experimental investigations was to establish the optimum hardfacing technology. The specimens were hardfaced in a single pass or several passes (layers) (Figures 2a to 2c), either with or without preheating. Hardfaced samples were cut into metallographic samples for tribological investigations (Figure 2d). Their hardness was measured along three different directions (see detail "A" in Figure 2d) and the microstructure of characteristic hardfaced-layer zones was estimated. The hardfaced-layer hardness was 551 to 742 HV1, while the microstructure was estimated as martensite-ledgeburite with retained austenite and excreted carbides at the grain

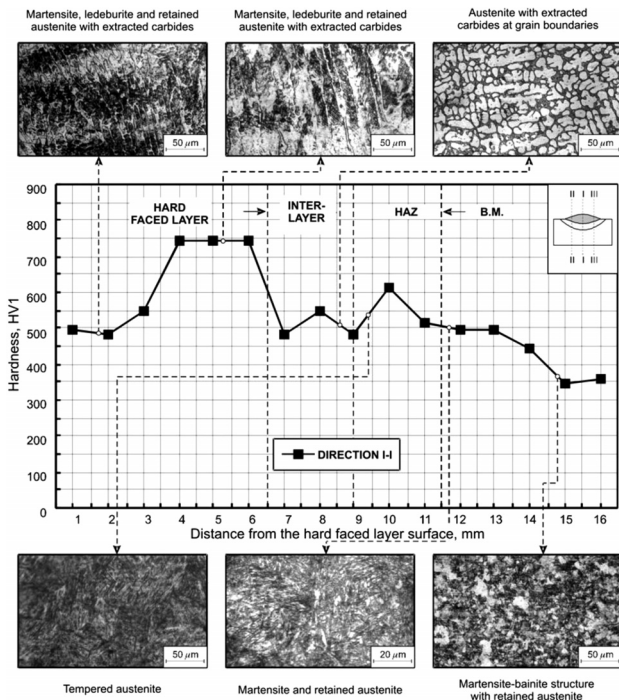
Figure 3: Hardness distribution and microstructures of characteristic hardfaced-layer zones (interlayer + two layers,  $T_0 = 20\text{ }^\circ\text{C}$ )

boundaries. The microstructure of the heat-affected zone (HAZ) was martensite with transitions into interphase structures, and the hardness was from 465 HV1 to 613 HV1. The microstructure of the interlayer was austenite-carbide, while its hardness was about 482 HV1. The hardness distribution and the microstructures of the characteristic zones are shown in Figure 3 for the three-layer hardfacing and in Figure 4 for the two-layer hardfacing with preheating<sup>5-8</sup>.

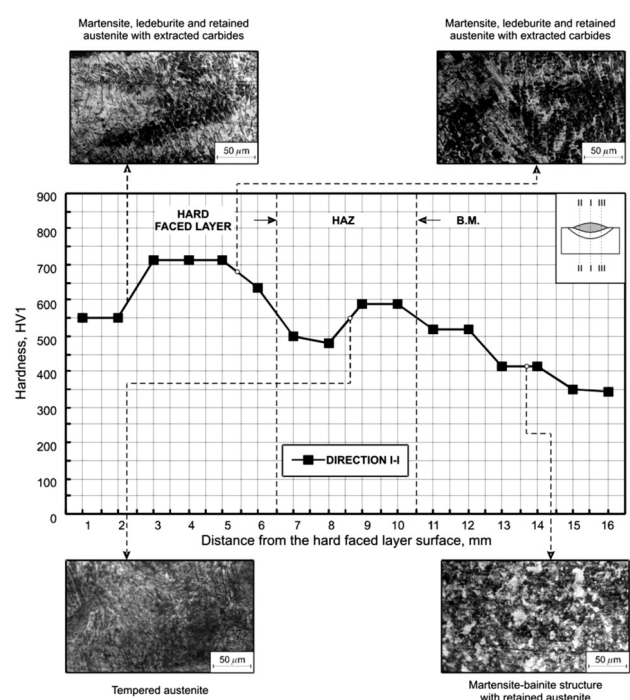
Figure 4: Hardness distribution and microstructures of characteristic hardfaced-layer zones (two layers,  $T_p = 200\text{ }^\circ\text{C}$ )

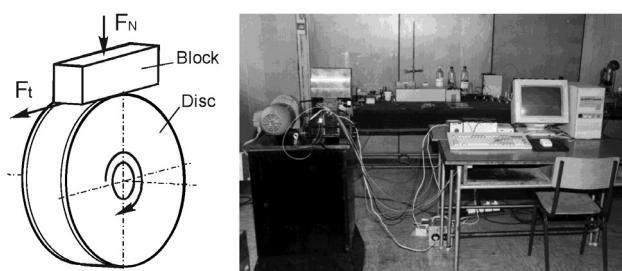
**Figure 5:** Tribometer TPD-93 and other measuring equipment for the performance of tribological tests

Tribological investigations were performed for a block-on-disk contact, on a TPD-93 tribometer (Figure 5) made at the Faculty of Engineering in Kragujevac. The aim of these investigations was to evaluate the resistance to wear of the base materials and deposited layers. Three prismatic samples (two from the hardfaced layer and one from the base material) were prepared for tribological investigations (6.5 mm × 15 mm × 10 mm).

During the investigations, the line block-on-disk contact was realized. The external variables of the tested samples were the contact forces, the sliding speed and the lubricant (motor oil GLX 2 SAE 15-W-40)<sup>4,5,8</sup>.

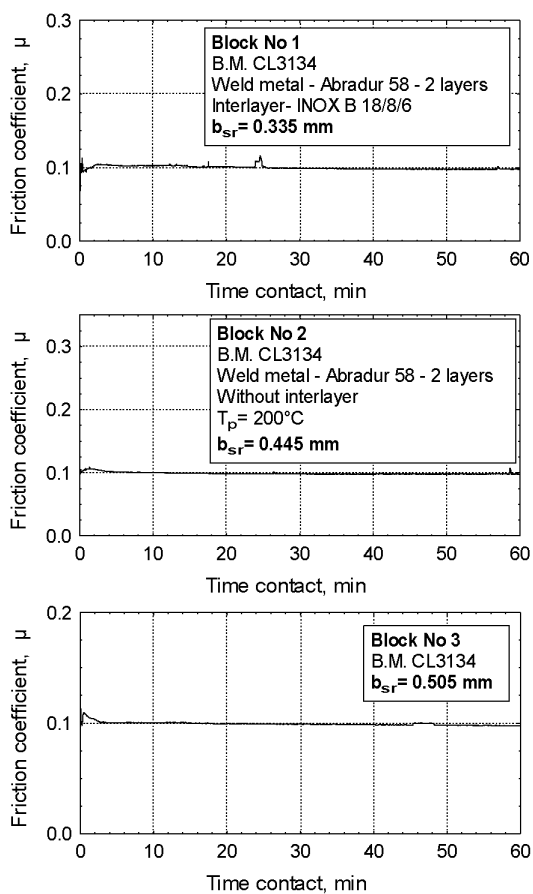
**Figure 6:** Friction-coefficient variation during the contact of 60 min (blocks 1, 2 and 3)

Prior to the investigations, the surface topography of blocks and discs was assessed with the computer measuring system Talysurf 6. The force  $F_N = 300$  N and sliding speed  $v_{kl} = 1$  m/s were adopted. During the contact time of  $\approx 60$  min, the friction-coefficient variation was registered (**Figure 6**). When the contact was terminated, the surface topography was assessed again and the

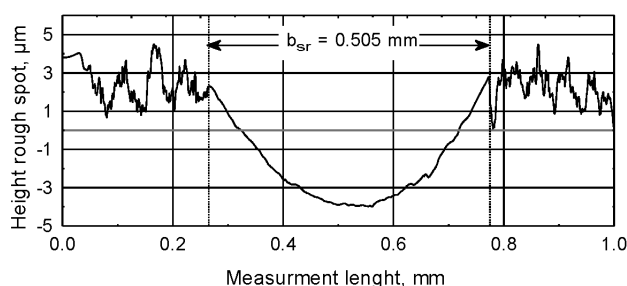
**Figure 7:** Wear scar – block No. 3 (after the contact of 60 min)

wear-scar widths of the blocks were measured (**Figure 7**). The wear-scar width was measured using a universal microscope UIM-21, with a magnification of 50 times<sup>4-9</sup>.

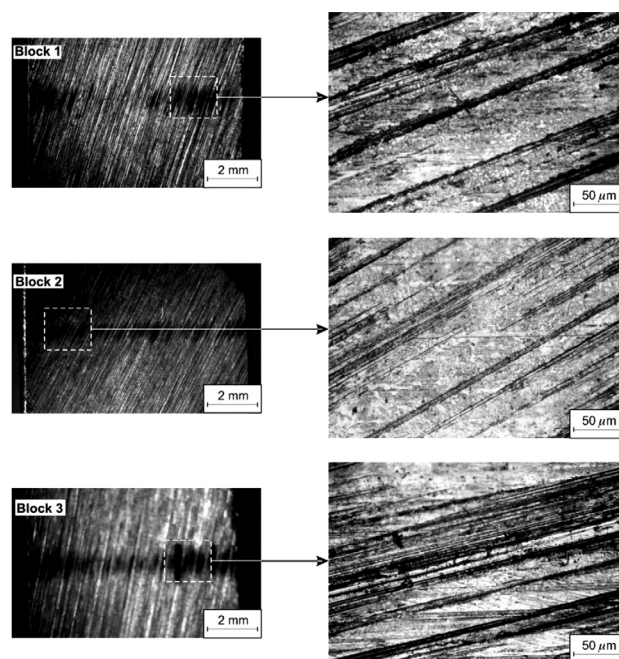
**Figure 8:** Wear of block Nos. 1, 2 and 3

Based on the results obtained with tribological investigations, the macroscopic and microscopic damages of the damaged blocks from **Figure 8** were assessed.

The measurements of the wear-scar widths showed that hardfaced layers have a significantly higher resistance to wear (especially those hardfaced without pre-heating) than the base material. This illustrates the importance of selecting the right hardfacing technology and filler materials for excavator/loader bucket teeth.

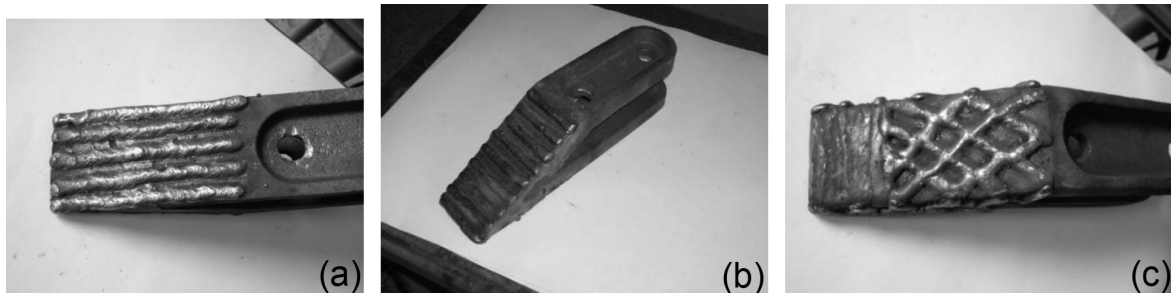
**Figure 9:** Hardfaced teeth with the layers deposited: a) longitudinally, b) horizontally and c) in a honeycomb pattern  
**Slika 9:** Zob s trdim navarom, položenim: a) vzdolžno, b) vodoravno in c) satasto

three-layer hardfacing (with an interlayer) was chosen. Hardfaced layers were deposited at the front and back sides – vertically over a tooth (**Figure 9a**), horizontally across a tooth (**Figure 9b**) or in a honeycomb pattern (**Figure 9c**). The width of the hardfaced layers was from 10 mm to 12 mm and the height was about 4 mm. Then, the hardfaced teeth were installed onto the central part of the bucket with the most intensive abrasive wear (**Figure 10a**, teeth 4, 5 and 6). The end teeth mounted on both sides were new (1, 2, 3 and 7, 8, 9).

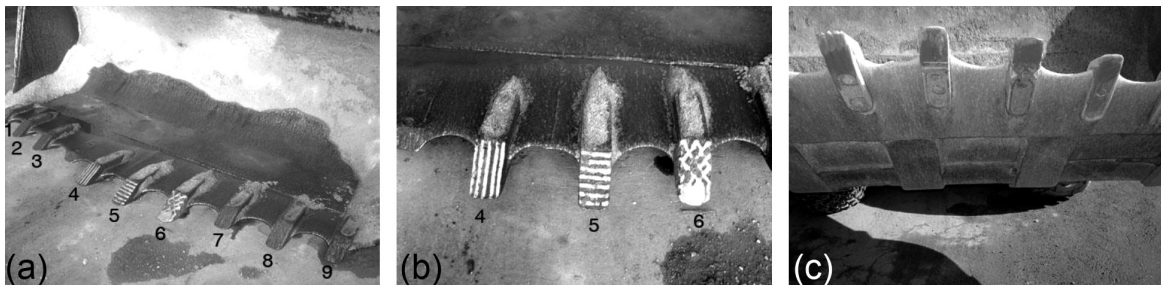
**Figure 10:** Bucket-tooth mounting sequence: a) front surface, b) back surface, c) teeth surface after 360 h of operation  
**Slika 10:** Zaporedje namestitve zob zajemalke: a) zgornja površina, b) spodnja površina, c) zobje po 360 h dela

The wear area was monitored and inspected after 360 h (**Figures 10a to 10c**), after 1600 h (**Figures 11a and 11b**) and finally after 3200 h of operation (**Figures 12a and 12b**)<sup>5,8</sup>.

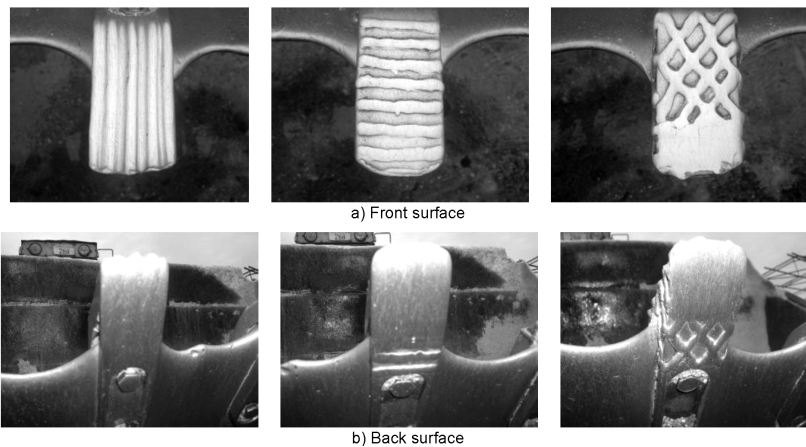
**Figure 11:** Hardfaced teeth after 1600 h of operation: a) front surface, b) back surface  
**Slika 11:** Zob s trdim navarom po 1600 h dela: a) zgornja površina, b) spodnja površina

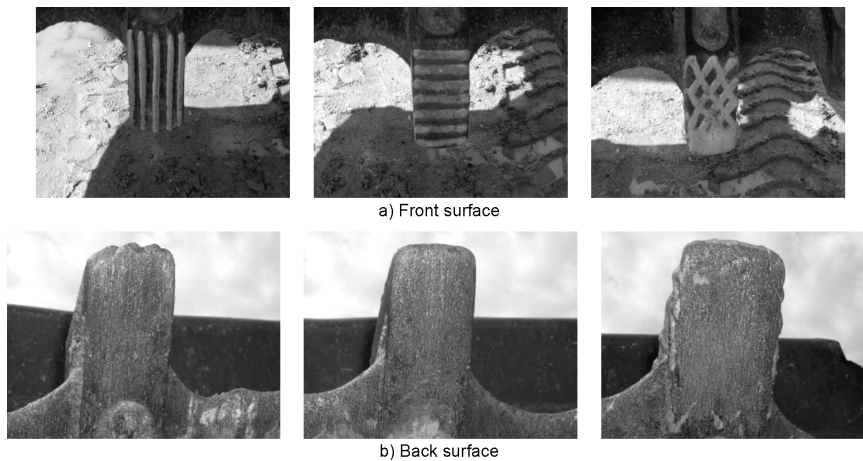
**Figure 12:** Hardfaced teeth after 3200 h of operation: a) front surface, b) back surface  
**Slika 12:** Zob s trdim navarom po 3200 h dela: a) zgornja površina, b) spodnja površina

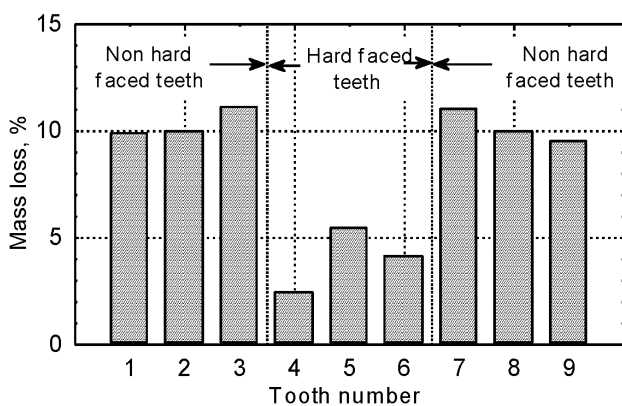
**Figure 13:** Diagram of mass losses for the non-hardfaced and hardfaced teeth

The teeth mass was measured before they were installed. After the teeth were used under real operating conditions for about 3200 hours, they were dismantled and their mass was measured again (**Table 4**). **Figure 13** gives the diagrams of mass losses for the new (non-hardfaced) and hardfaced teeth.

The greatest resistance to the abrasive wear (loading of crushed stone material) was exhibited by the teeth with the hardfaced layers applied vertically, followed by the teeth with the hardfaced layers deposited in a honeycomb structure, while the teeth with the horizontal hardfaced layers showed the least wear resistance. The best hardfacing patterns for the other conditions of the abrasive wear require a further investigation<sup>5,8</sup>.
