# GROUTING AND INJECTION TECHNIQUES TO REPAIR CRACKS AND WATER LEAKAGE AT THE RENUKA DEVI TEMPLE, CHANDRAGUTTI, INDIA

Gautham Hareendranathan<sup>1</sup>, Jeny Jairaj Stella<sup>1</sup>, Thirumalini Selvaraj<sup>1\*</sup>,  
Nambirajan Murugan<sup>2</sup>

<sup>1</sup>Department of structural and geotechnical Engineering, School of Civil Engineering, Vellore Institute of Technology (VIT), Katpadi Road, Tamil Nadu-632014, India

doi:10.17222/mit.2019.250

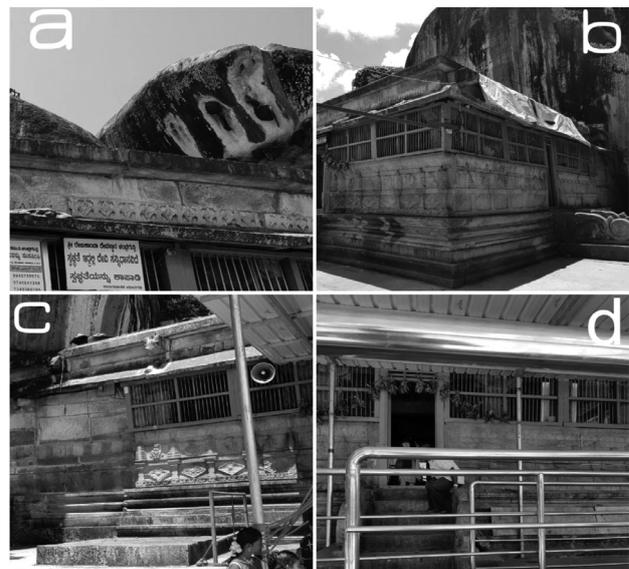
**Figure 2:** Renukadevi Temple, Karnataka, India: a) top view of the temple, b, c) side view, d) entrance to the temple

A building that faces a water-logging problem is the 300-year-old Renukadevi Temple (**Figure 2**), located in Chandragutti, Karnataka, India. The roof of the temple has cracks that emerged due to the percolation of stagnant water through the material. This led to the formation of cracks on the roof, which started to damage the temple structure. The main aim of the present study is to characterize the ancient lime mortars used for the roof slab, using a mineralogical and acid-loss analysis. After adopting the ancient knowledge of using an organic additive for lime mortars as the repair material, we designed a compatible grout for waterproofing and strengthening the lime mortar.

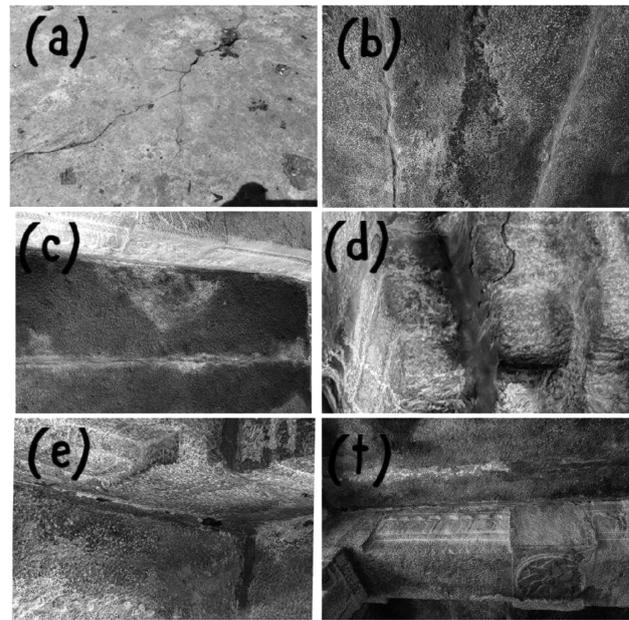
**Figure 4:** a) Cracks on the top surface of the roof, b, c, d) inner surface of the roof, e, f) junction of the roof and wall

During the past years, there has been a slow development of cracks (**Figure 4**) and voids on the top surface of the roof slab, leading to gradual water seepage from the roof to the walls of the temple. A total of five powdered or uncrushed lime-mortar samples were collected (**Table 1**). Three bedding lime mortars were collected from the rooftop and two lime plasters were collected from the walls of the temple. All the samples were collected from higher areas to avoid the effects of a capillarity rise of water and salts. Sufficient quantities of the samples collected were used for mineralogical analyses such as FT-IR and X-ray diffraction.

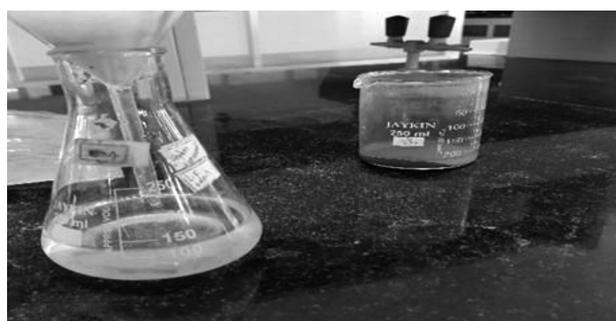
**Figure 5:** Acid-loss test

The ratio of the binder and filling material is determined with an acid-loss analysis. Lime is used as the binder of aggregates, as the filling material. The ratio is determined by treating samples with dilute hydrochloric (0.1N) acid. The samples were gently crushed and 10 g of gently crushed samples were mixed in a beaker of 500 mL along with 200 mL of distilled water (**Figure 5**). To that 30 mL of hydrochloric acid (0.1N) was added; the mixture was continuously stirred for 1 h and then filtered out using filter paper. The residue remaining on the filter paper was the binder and the residue in the beaker was the aggregate.

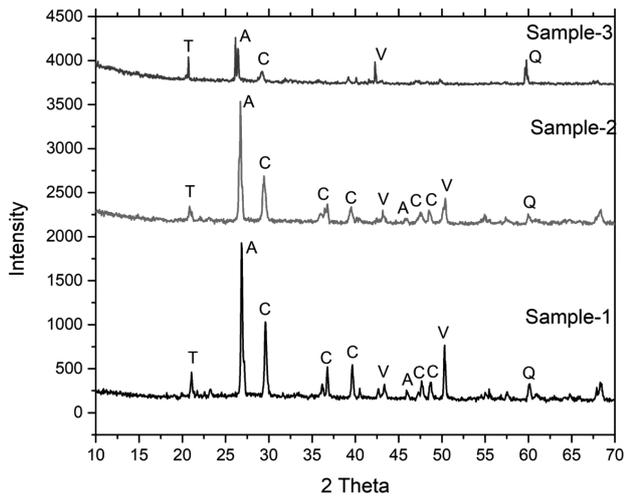
**Figure 6:** XRD of the roof samples: C: calcite, A: aragonite, V: vaterite, P: portlandite, T: tobermorite, Q: quartz

The XRD results of the roof and walls are presented in **Figures 6, 7**. The results are presented in **Table 3**. Both the roof and wall samples show the presence of calcite, aragonite, vaterite, quartz, calcium oxide and tobermorite (calcium silicate hydrate). Hence, it is clearly understood from the formation of tobermorite that the lime was hydraulic as a tobermorite formation is only possible in the presence of clay impurities, which initiate the hydraulic reaction. Article<sup>34</sup> discusses the presence of tobermorite in Roman marine concrete. The pozzolanic action of volcanic ash with lime in the presence of seawater significantly contributed to the durability of a 2000-year-old Roman marine concrete structure. The alkaline condition of seawater, carbonation reaction and cation exchange created an environment for the precipitation of tobermorite as explained by article.<sup>35</sup>

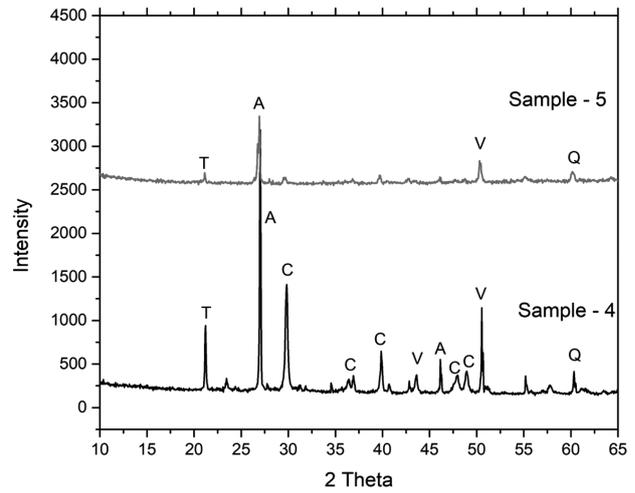
**Figure 7:** XRD of the wall samples: C: calcite, A: aragonite, V: vaterite, P: portlandite, T: tobermorite, Q: quartz

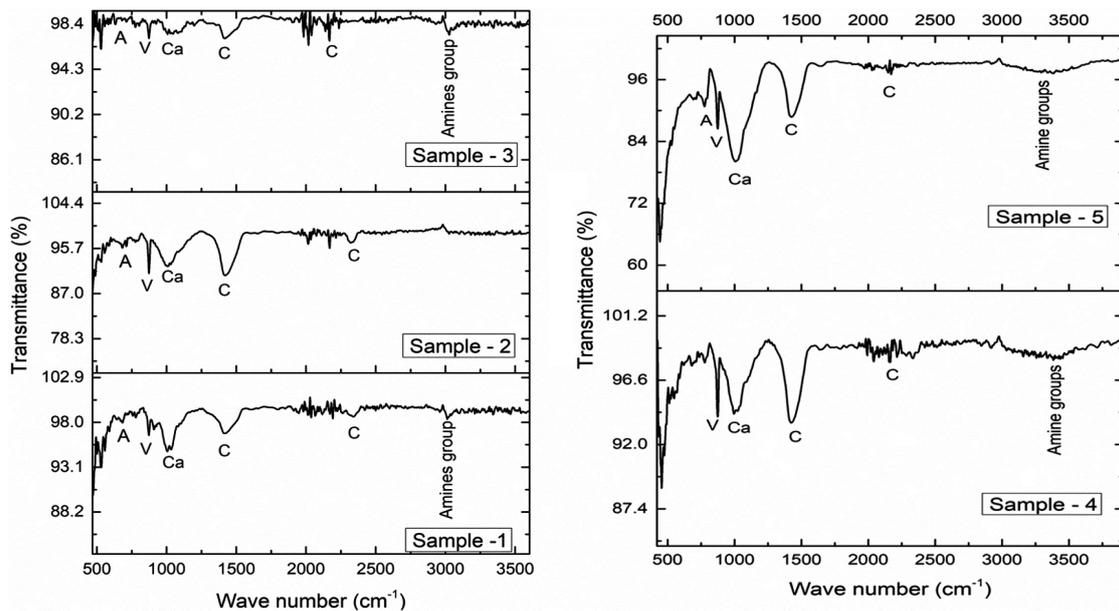
**Figure 8:** FT-IR of the roof samples: Ca: carbohydrate, C: calcite, A: aragonite, V: vaterite, P: portlandite, T: tobermorite, Q: quartz

in the presence of organic additives in the form of sucrose, tobermorite can precipitate along with calcium carbonates from lime mortars.<sup>36,37</sup> The FT-IR results presented in **Figure 8** confirm the formation of the minerals identified with XRD, also indicating the presence of carbohydrates and amino acids in the mortars. Therefore, the presence of carbohydrates and proteins indicated by

the FT-IR results supports the traditional practice of adding kadukkai (*Terminalia chebula*), a plant rich in carbohydrate, in the presence of jaggery (unrefined sugar) after the fermentation to lime mortars during the time of mixing.

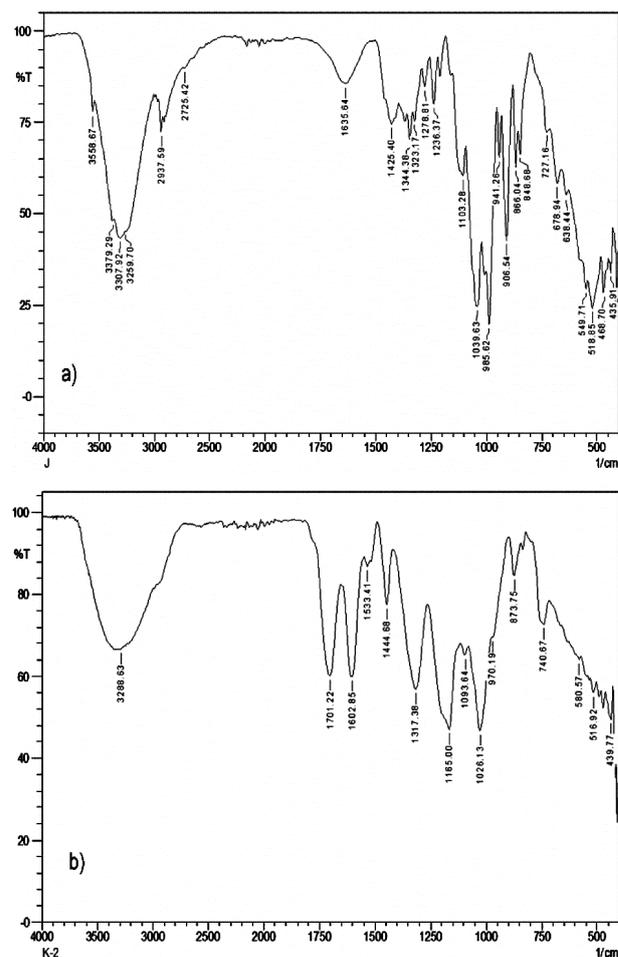
Figure 9: FT-IR graphs: a) jaggery, b) kadukkai

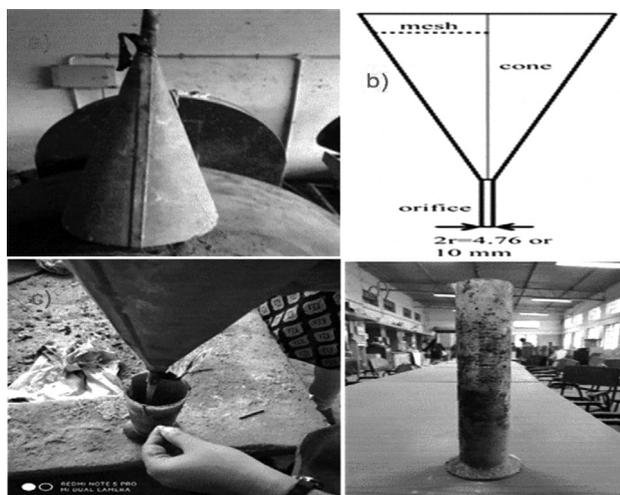
**Figure 10:** a), b), c) Marsh-cone test; d) stability

A Marsh cone was cleaned and used as shown in **Figure 10**. The slurry was poured through the Marsh cone at a constant rate. Another bucket was placed below the orifice of the cone and a stopwatch was used to record the time taken for the slurry to flow from the Marsh cone to the container at the bottom. The flow time for the cement-and-lime paste should not be longer than 15 s.

From **Table 4**, it is clear that the organic water meets the required criteria. The Marsh-cone test is a reliable and simple method (**Figure 10**). The principle is always the same, but the test geometry depends upon the standard and application. The fluidity of the material depends on the flow time, which is the time required by the material to flow out of the cone.<sup>27,29</sup> The Marsh-cone test is needed for determining the level of relative fluidity.

The property of the grout to sustain its homogeneity during application and until its hardening is called stability. Stability ensures that bleeding and segregation are avoided. Low segregation helps to maintain the consistency of the grout. The volume change may be either an increase or decrease in the volume. The stability of a grout can be obtained experimentally through ASTM 940.<sup>28</sup> With both water and organic water addition, there is no segregation of the binder and liquid and no distinct colour or texture change (**Figure 10**).
