ROLE OF RESIDUAL STRESSES ON FRACTURE PROPERTIES OF UNDER-MATCHED BUTT WELD

Inoslav Rak, Vladimir Gliha

Under-matched weld joints were adopted for producing a penstock of 47 mm wall thickness and 4200 mm diameter, to improve the weldability. The isothermal Robertson wide plate test on the under-matched weld joints, where the allowable stress level was 0.6 of the yield stress, proved that the longitudinal stresses caused the crack propagation along the weld joint to deviate into tough base material where it was arrested. The arrest temperature was between -10 and -20°C. The behaviour of the crack propagation was the reason to omit the thermal stress relieving of the pipe sections and on circumferential weld joints executed at the site. One can always take into consideration the role of axial residual stresses when assessing whether to use, or not, under-matched weld joints in severer loaded structures.

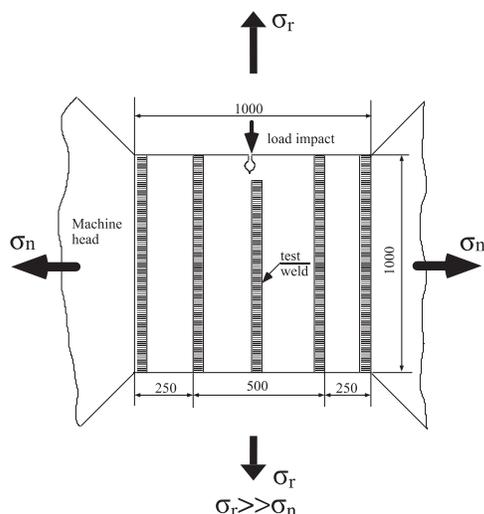
Figure 1: Dimensions of the specimen and its assembly in the tensile machine for isothermal Robertson test

The fracture initiation points at the end of each specimen were saw cut in the HAZ of the tested weld joint (composite notch). The specimens were cooled to the testing temperature, while the initiation point was additionally cooled with liquid air. A brittle fracture was then initiated by a hammer impact. The scheme of the specimen preparation and the assembling into the tensile machine can be seen in **Figure 1**. The results of the Robertson tests executed at different temperatures are shown in **Table 5**.

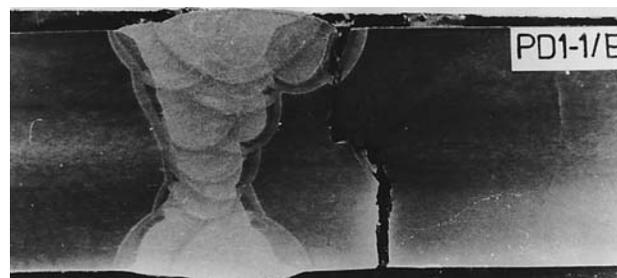
Figure 2: Macro graph of specimen PD.1-1 at a distance of 300 mm from the lower edge plate

| Designation | Testing Temperature ($^{\circ}\text{C}$) | Fracture path |
|---|--|--|
| PD. 1-1 | -22 | After HAZ fracture initiation, at a distance of approximately 100 mm the fracture deviated mainly into the BM but did not arrest there until the end, see Fig. 2 |

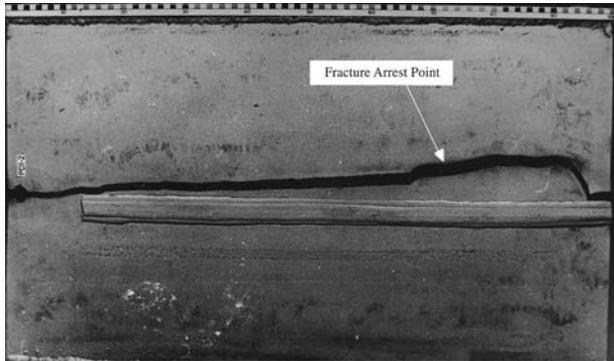
Figure 3a: Specimen PD.1-2 after testing
Slika 3a: Preizkušaneč PD.1-1 po preizkušanju

| Designation | Testing Temperature ($^{\circ}\text{C}$) | Fracture path |
|---|--|--|
| PD. 1-2 | 0 | After HAZ fracture initiation, at a distance of approximately 100 mm the fracture deviated into the BM and arrested at distance of 660 mm from the plate edge end, see Fig. 3a and 3b |

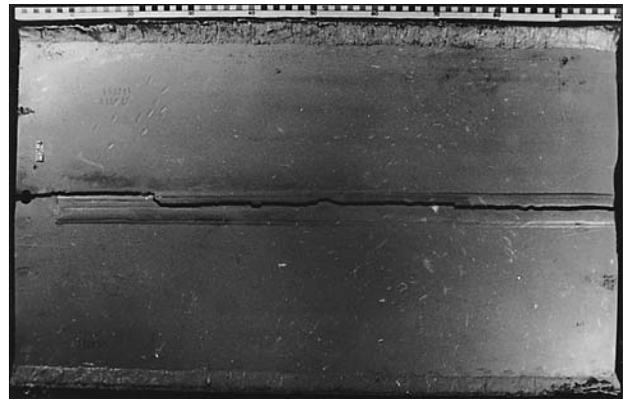
Figure 5a: Fracture path of specimen PD.1-4 after the Robertson test at -20°C

| Designation | Testing Temperature ($^{\circ}\text{C}$) | Fracture path |
|---|--|--|
| PD. 1-4 | -20 | After HAZ fracture initiation, fracture deviated at a distance of 50 mm from the plate edge end into the BM, propagated in the BM until approx. 240 mm from the plate edge end and then deviated to the under-matched WM, the specimen fractured over its entire length, see Fig. 5a and 5b |

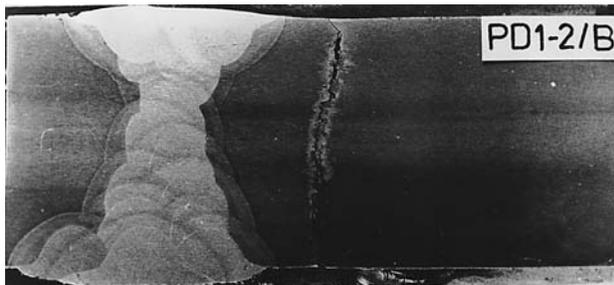
Figure 3b: Macro graph of specimen PD.1-2 at a distance of 300 mm from the HAZ saw cut notch

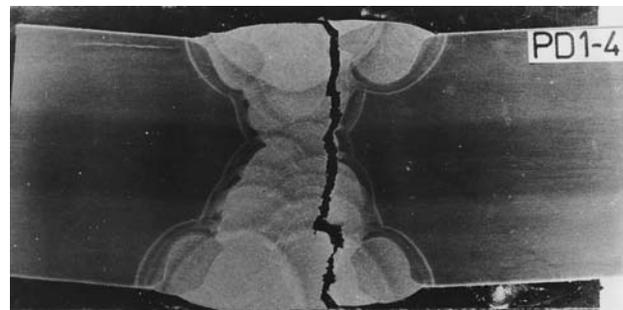
Figure 5b: Macrograph of specimen PD.1-4 at a distance of 500 mm from the upper edge of the plate

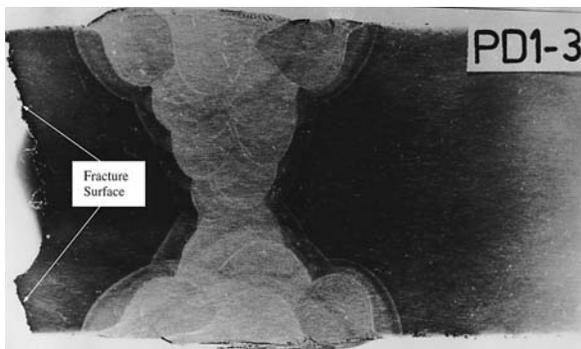
Figure 4: Macro graph of specimen PD.1-3 at a distance of 150 mm from the HAZ saw cut notch

| Designation | Testing Temperature ($^{\circ}\text{C}$) | Fracture path |
|---|--|--|
| PD. 1-3 | -10 | After HAZ fracture initiation, at a distance of approximately 20 mm the fracture deviated into the BM and arrested at a distance of 170 mm from the plate edge end, see Fig 4 |
